# Facility Water Analysis and Water Efficiency Opportunities

**AMGEN Pharmaceuticals**  
ATO Campus

Edward J. Brady CEM, LEED-GA, ARCSA-AP  
Water Efficiency Technologies LLC  
[edbrady@waterefficiencytech.com](mailto:edbrady@waterefficiencytech.com)  
(775) 399-5991

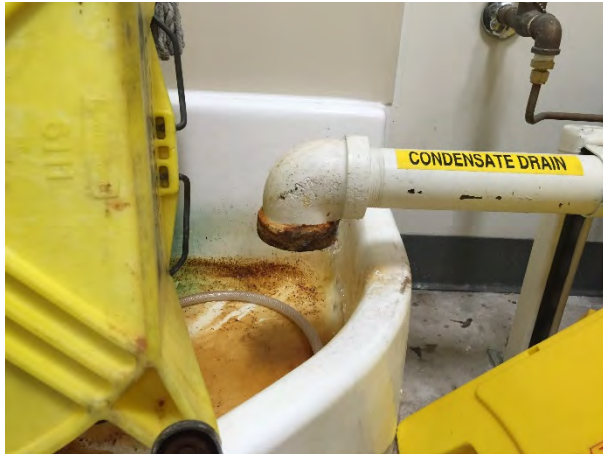
## BUILDING 6 – PHOTO'S

1<sup>st</sup> Floor Janitor's Closet – Failed  
Solenoid on HEX Quench Line

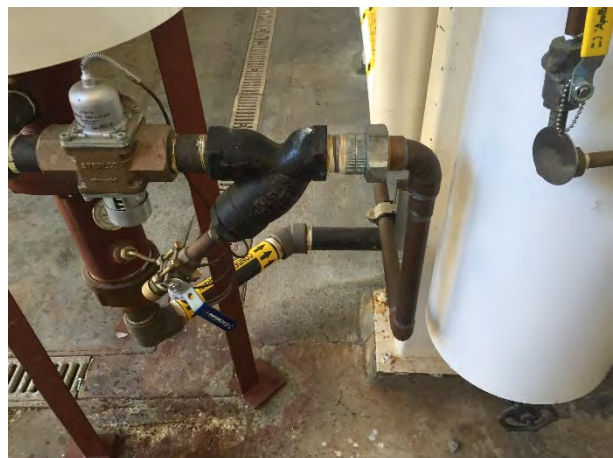
HW Skid – rear of B6, with  
temperature probe and  
'functioning' Solenoid Valve

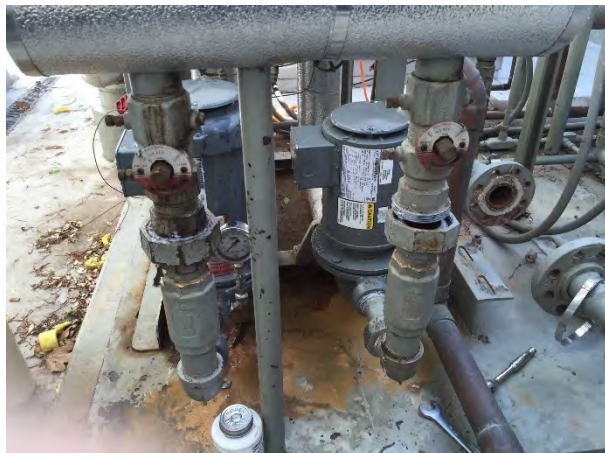
## BUILDING 10 – PHOTO'S

Utility Yard – Condensate Pump removed and draining to sewer

1. Building is on Campus Steam and CW Loop
2. Abnormal drop in water use during July of 2014; approximately 775,000-gallon reduction
3. Abnormal drop in water use during Jan of 2015; approximately 750,000-gallon reduction
4. The condensate pump in the utility yard was removed and 100% of the steam condensate was being sent to drain. It had been in that condition for the entire two months that we were performing the audit.

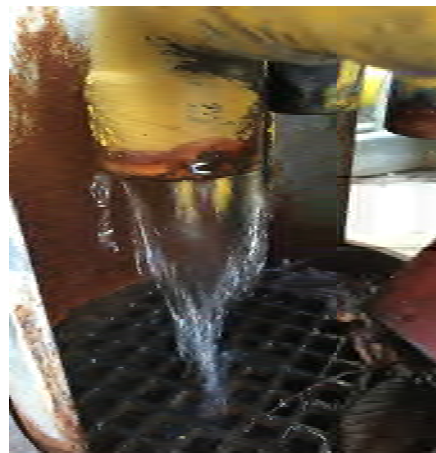
Condensate Tank Valve – Open to Drain. Pump was removed for over a month.

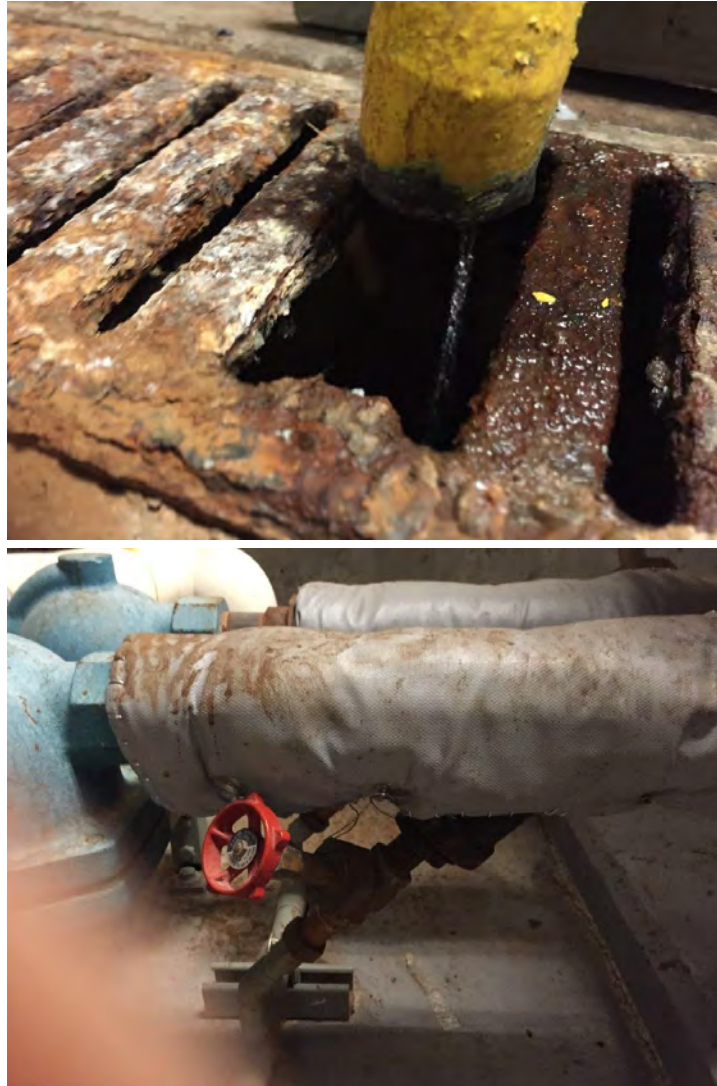
Basement – Strainer valves  
before steam traps are not  
holding - .25 gpm of condensate  
to drain (HX – 1 – 1)

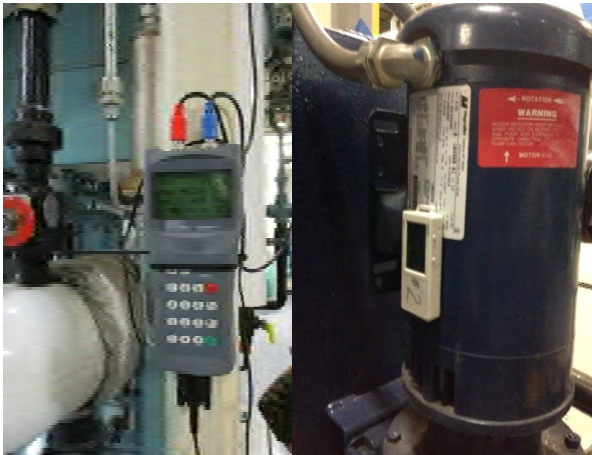
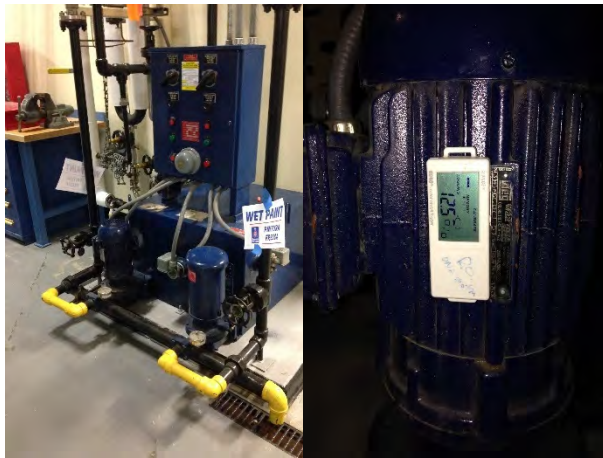
## BUILDING 18N/18S - PHOTO'S

Data loggers / Ultrasonic flowmeters on boiler feed-water pumps – 100% RO water feed.

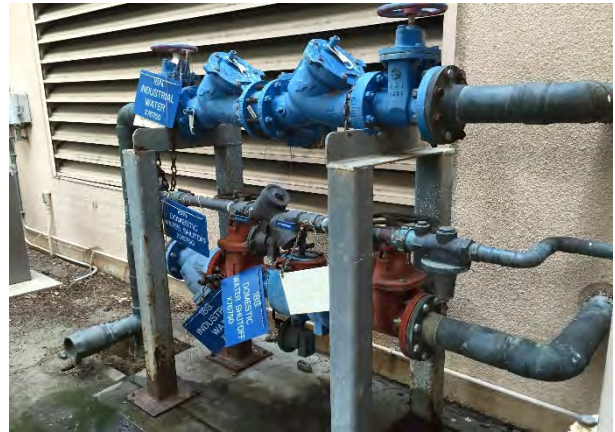
Main meter for B18S, is actually split into three (3) separate lines marked as 18N Industrial, 18S Domestic and 18N Domestic

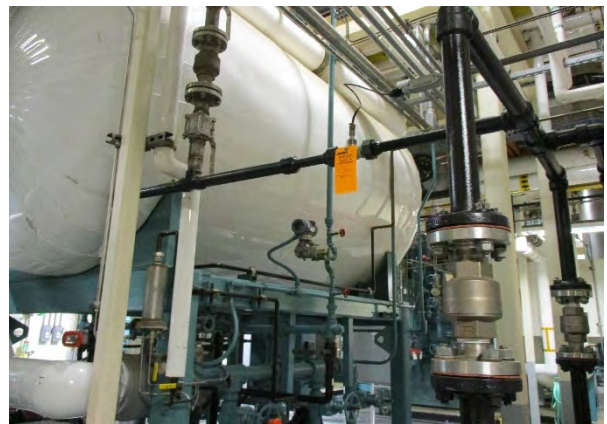
Stainless 'In-Line' flowmeter installed to measure boiler feed-water was inoperable for the three months we were onsite.

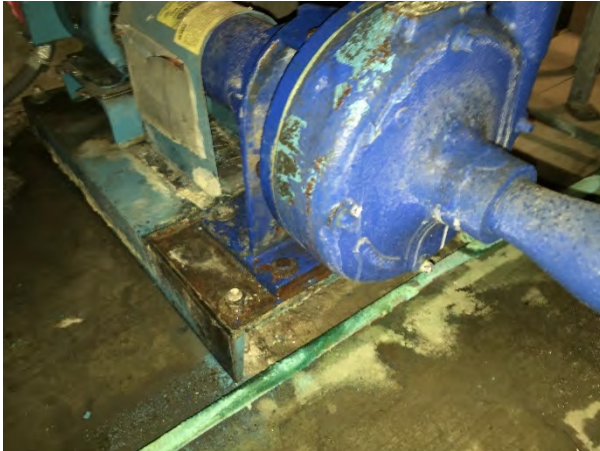
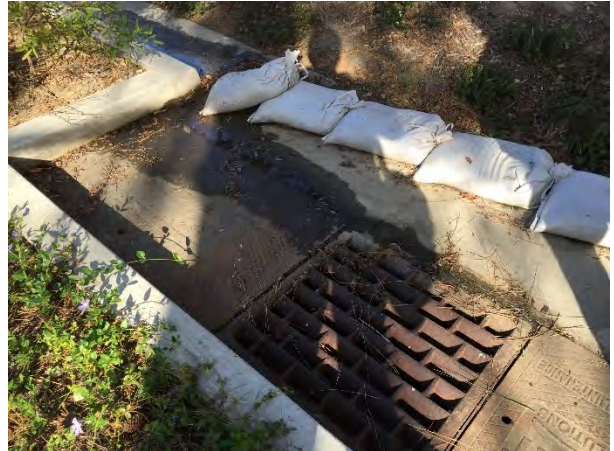
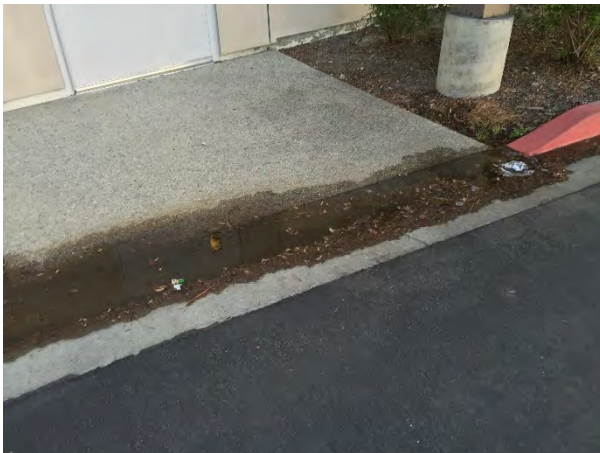
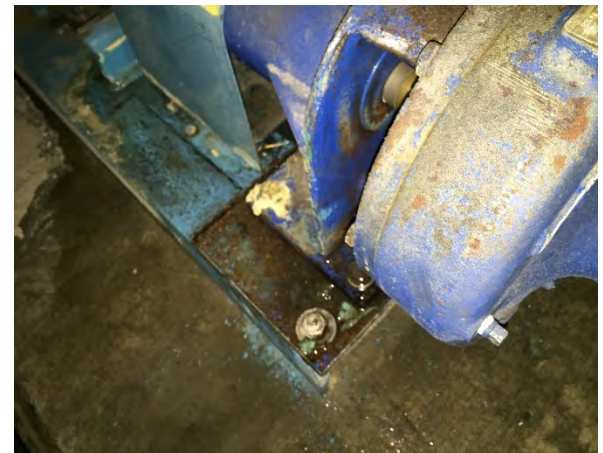
1. Building is on Campus Steam and CW Loop
2. Heating Hot Water is provided by an independent HW skid, outside of building. The pump seals were leaking hot condensate in the sanitary sewer, as of our last visit in March of 2016
3. April and May of 2015 saw large usage spikes with no apparent explanation.

Hot Water Skid Leaking from the Pump Seals and Housings. Hot condensate with Boiler chemicals is flowing to the Sanitary Sewer

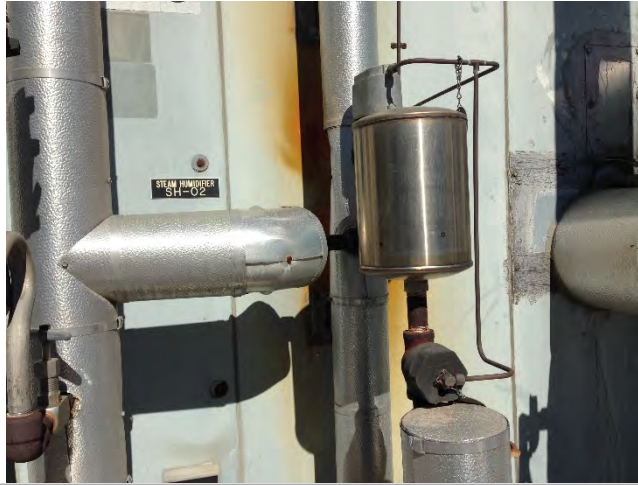
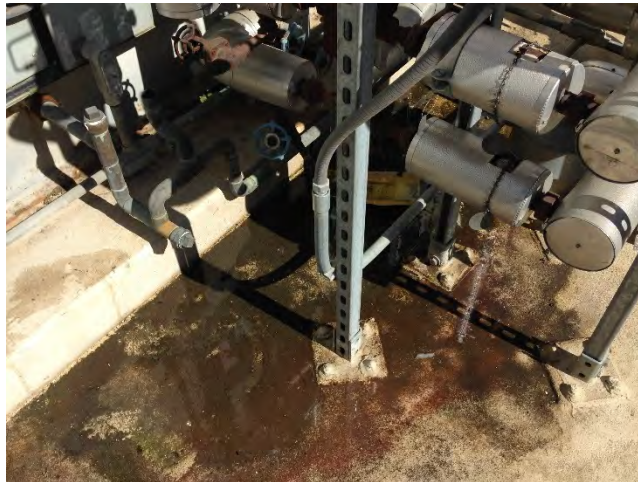
Leaking Steam Trap (Humidification) –  
leaking condensate on roof

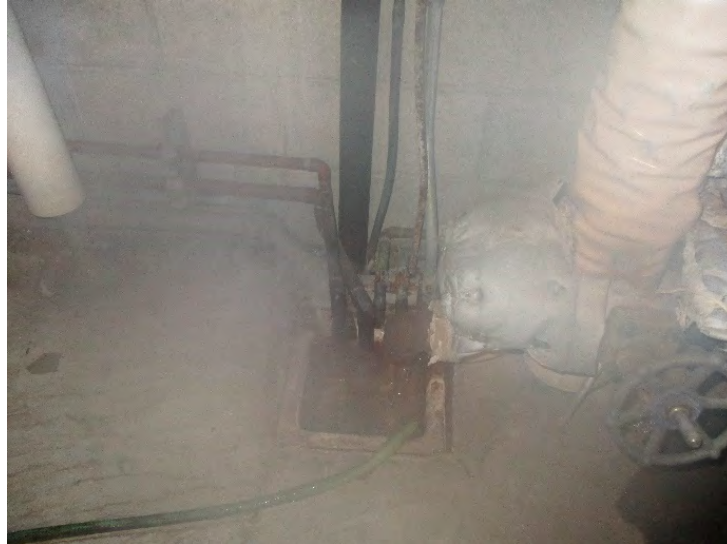
1. Building is on Campus Steam and CW Loop
2. Meter Data and Demographics for all Three Buildings Combined in Water Balance
3. Condensate return was open to drain, and not being sent back to 18N. Engineering claims that buried pipe is corroded and leaking.

Condensate return was open to drain, and not being sent back to 18N, due to failure of a buried condensate return line

Replace existing 'buried' condensate lines with pipe made from insulated Stainless Steel, like the Perma-Pipe 500. The cost of RO water at approximately \$2 /gal plus the heat and chemical costs, will provide an **ROI of under 2 years**.

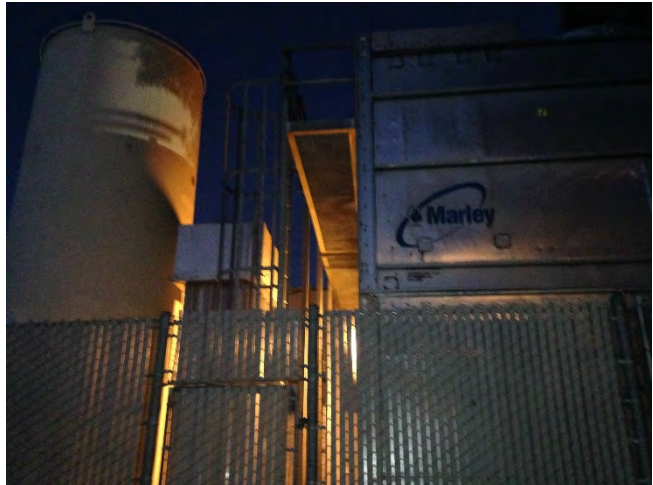
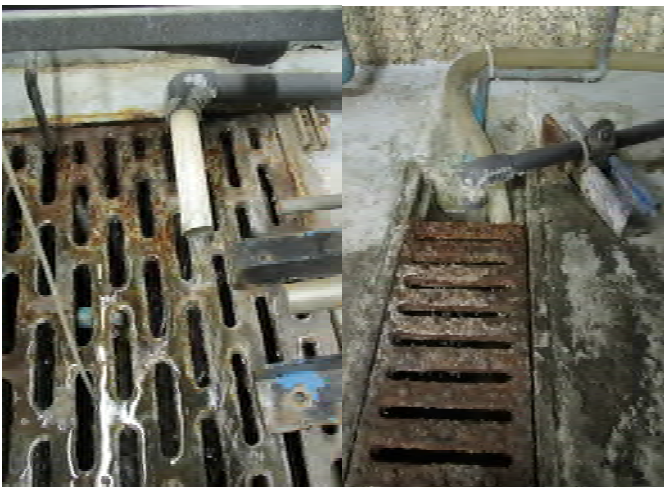
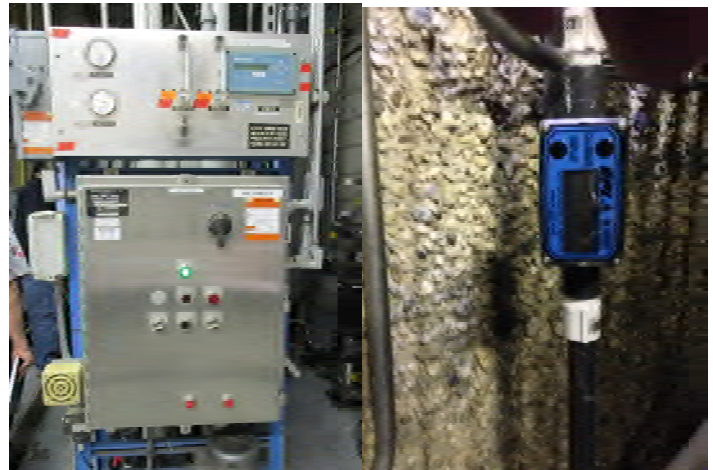
## BUILDING 99 – PHOTO'S

One of the 2 – RO Systems supplying Building 99 with Pure Water. We installed an inline flowmeter and tested the water for use as Cooling Tower Make-up.

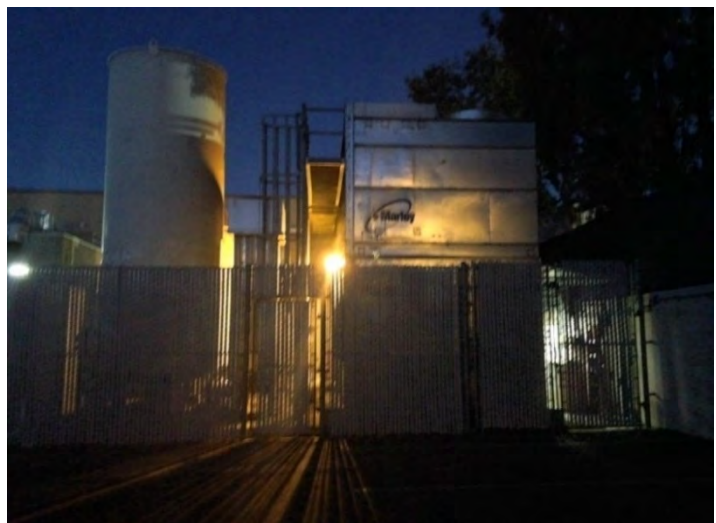
We tested two RO reject water samples for various markers;  
*the results are included in the Appendix.*

| <u>RO is running at 60% Reject / 40% Product</u> (3 gpm reject / 2 gpm Product) | | | | |
| <u>Building 99</u> - Reverse Osmosis Reject ( <i>effluent</i> ) | | | | |

Just outside of the mechanical room that houses the two RO systems in building 99 are a pair of Marley Cooling Towers. According to the make-up meters, these towers use **1.1 million gallons of water each year**. The cost of the cooling tower make-up water at current rates is:  $1,116,500 / 1000 * 6.24 = \$6,966$  /year

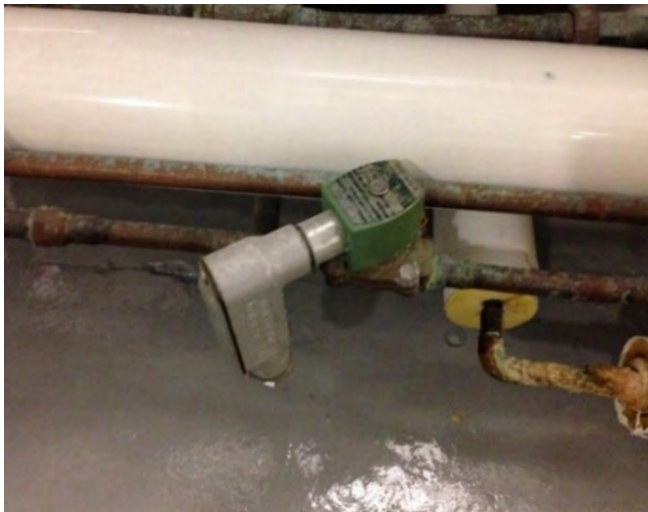
Both the Gravity and Vacuum sterilizers use city water to quench the effluent to meet the city code of 140-degree discharge. Substantial water savings will be achieved by replacing the existing cold water quench with a retrofit kit designed to monitor the effluent discharge temperature, and quench with cold city water only when necessary. Amgen has several of these installed, but a large number of the solenoids are not functioning correctly, or are failed 'open'

Solenoid on Amgen's city water  
'quench' line that is failed

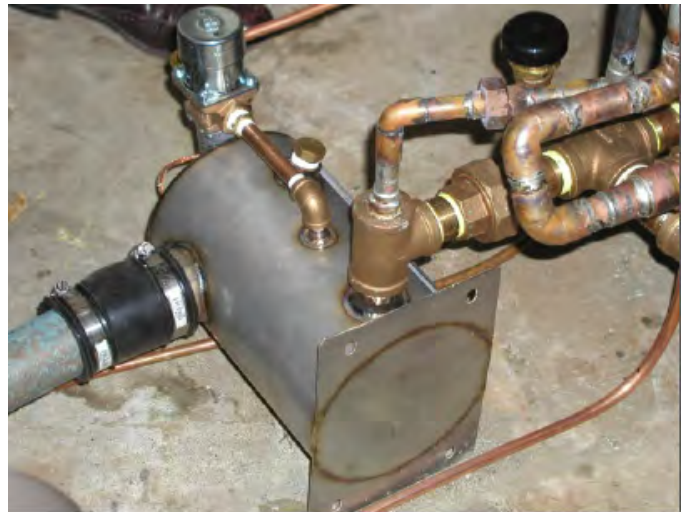
Example of a 'custom made' quench pot  
that is functioning correctly

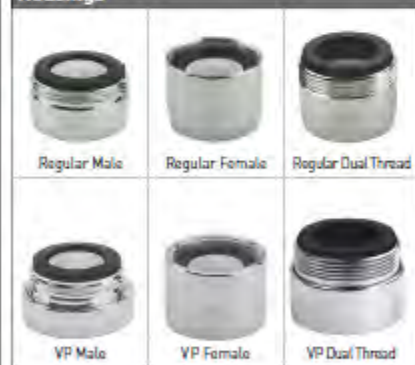
#### Housings

Materials: Body Acetal  
O-ring EPDM  
Washer EPDM  
Wetted surface area: 4834.0 mm²
