## WELLJET/KAC REHABILITATION CASE STUDY: JPMC WELL #9

The WellJet/KAC rehabilitation program began with Well #9. Drilled in 1991, to a total depth of 774' (236m), 13" ID (33cm), with wire-wrapped screen perforations from 534-761' (163-232m).

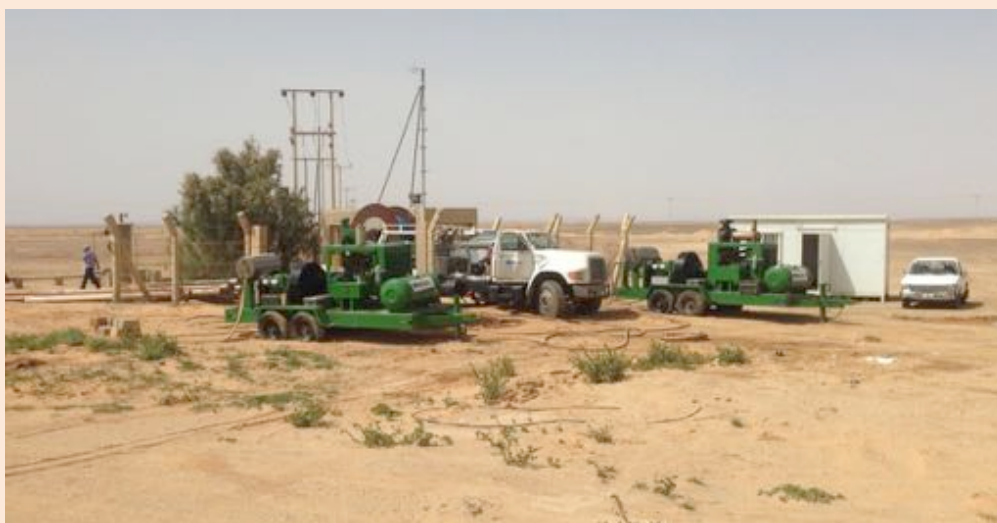
*WellJet operations at JPMC Well #9*

WellJet jetted the entire perforated area with its patented high-pressure tool and process, removing the obstructions inside the screened area and penetrating into the gravel pack to break up harmful deposits preventing free water flow. At JPMC's request, WellJet also blasted the blank casing to remove buildup of iron scale.

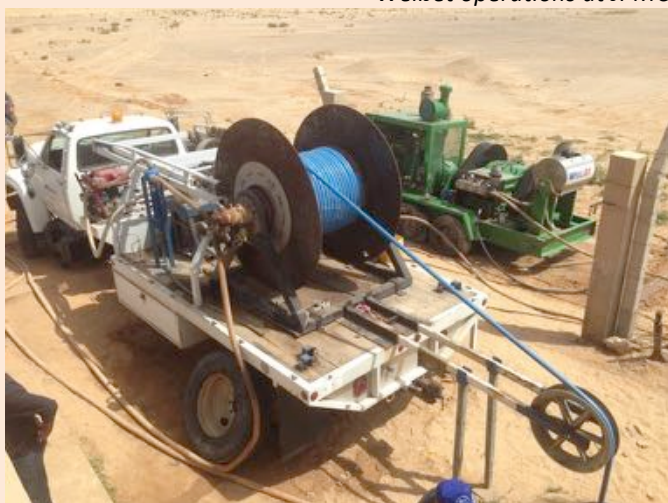
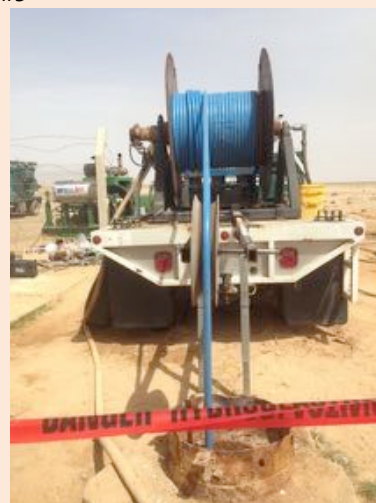
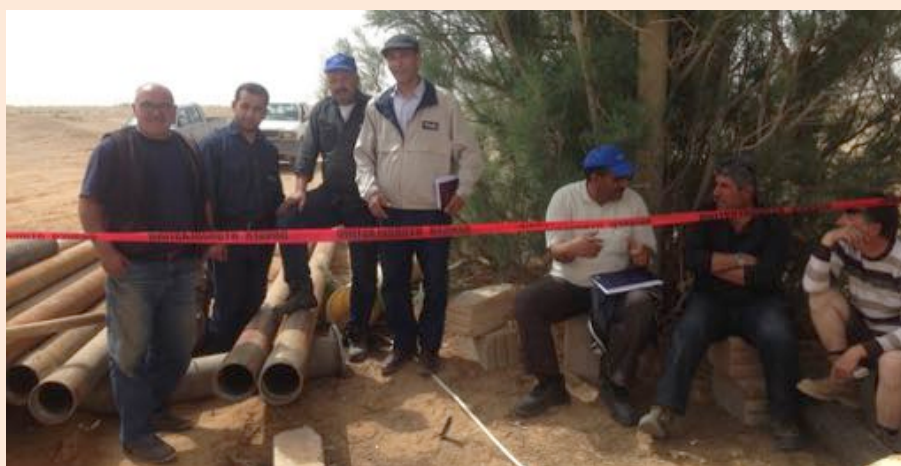
*JPMC personnel observe high-pressure jetting from behind safety barrier*

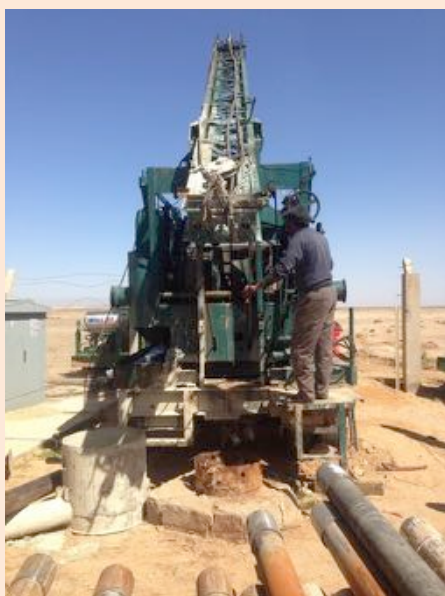
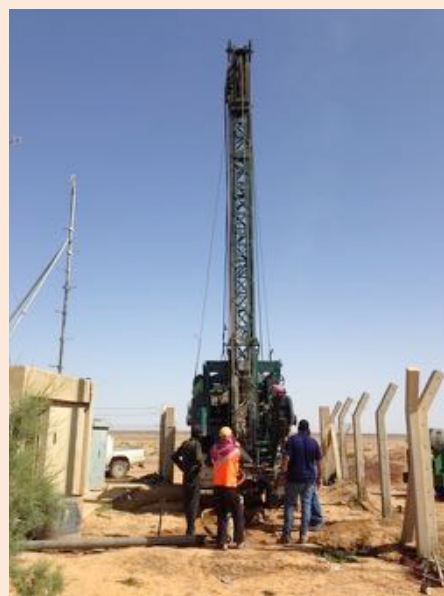
Jetting was followed by bailing and dual-swab surge-blocking to remove more than 130' (40m) of fill that came in from the jetting process:

Proper surging and fill removal are essential elements in the WellJet program.

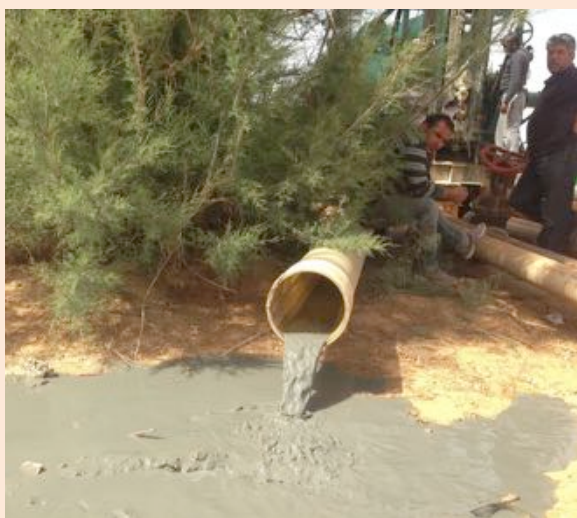
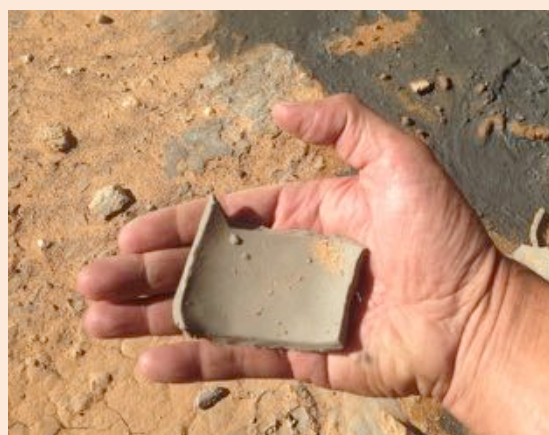
*The fill was a mixture of drill mud, fine sand, and iron scale:*

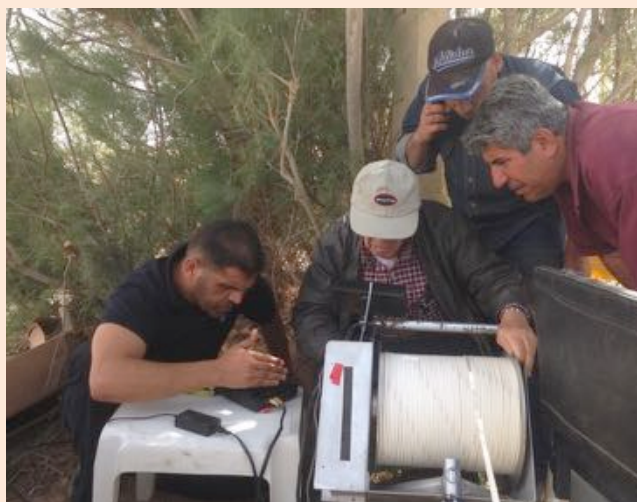
Downhole video showed extreme plugging throughout the screened area, as well as heavy buildup of iron scale on the blank casing.

Downhole video was recorded to provide Before/After visual comparison:

*Before/After video shows how WellJet removed obstructions and opened plugged perforations.*

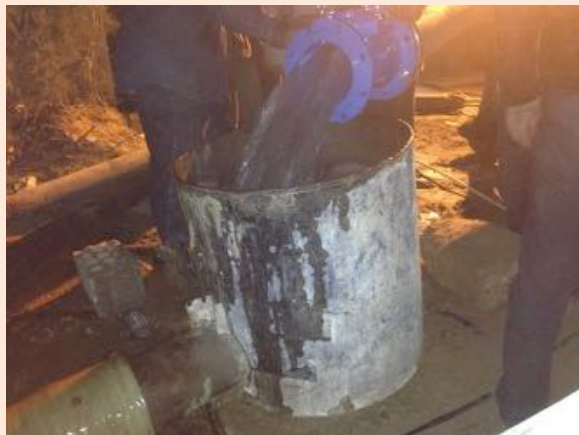
Test pumping was conducted over the next two days. To enable a direct Before-and-After comparison, the exact same pump equipment, calibration and specifications were utilized and followed as prior to the rehabilitation:

*At first, 20 minutes of black water...*

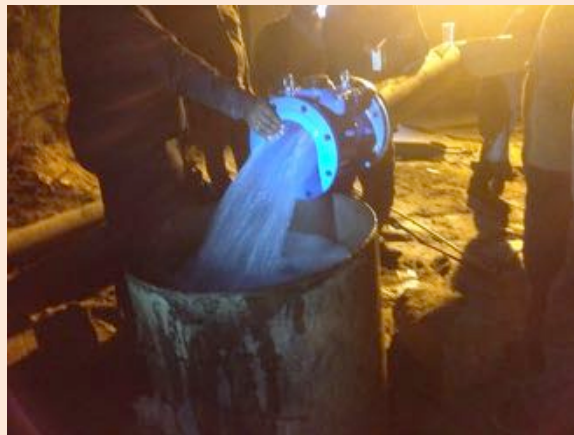
*Then clear.*

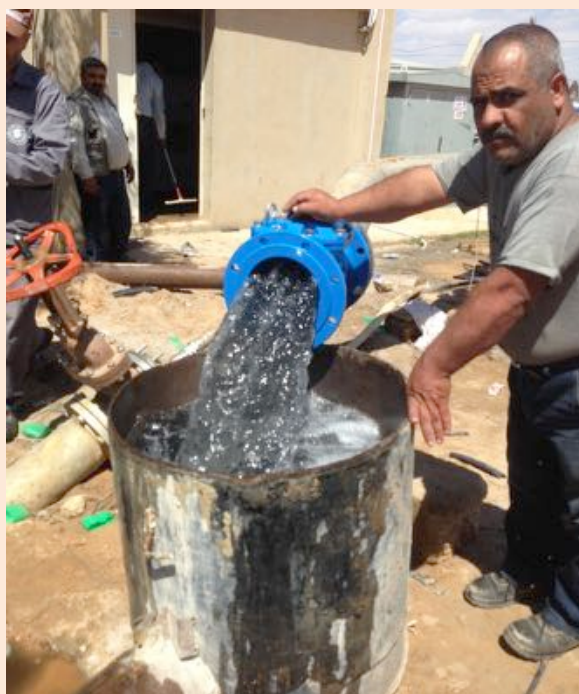
*The next day, just 3 minutes of black water...*

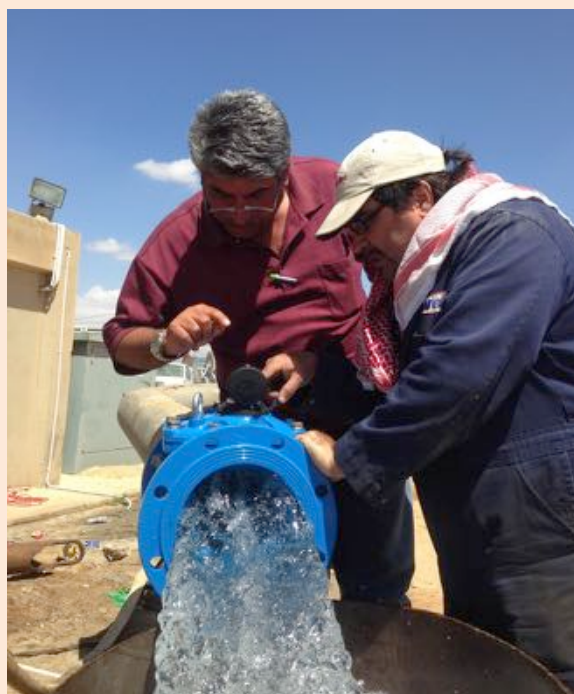
*Then clear.*

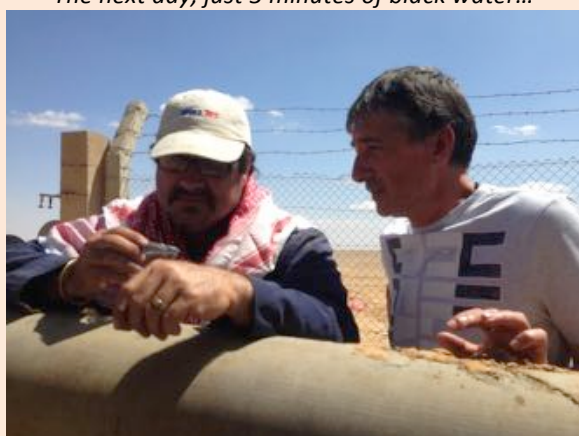
*WellJet inventor Jeff Glass and KAC partner Mansour Khost examine flowmeter results.*

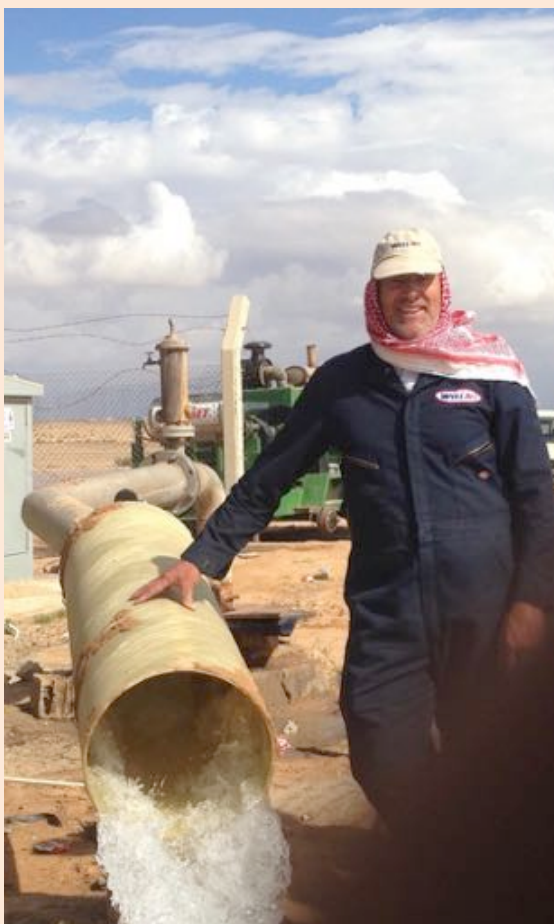
**Post-Rehab Performance:**  
**630 gpm (143 m<sup>3</sup>/hr) –**  
**drawdown 29' (8.8m) - 21.7**  
**Specific Capacity**

**79% increase in water flow:**  
**350 gpm (80 m<sup>3</sup>/hr) before, 630**  
**gpm (143 m<sup>3</sup>/hr) after**

**648% increase in efficiency (2.9**  
**Specific Capacity before, 21.7**  
**Specific Capacity After)**
