Technical Report

ATLANTIS & SIMONSTOWN WELLFIELDS

*OUTCOMES OF REHABILITATION AND REGENERATION PROJECTS 1999-2001 &
2014-2016 OF POTABLE WATER SUPPLY BOREHOLES FOR IMPLEMENTATION*

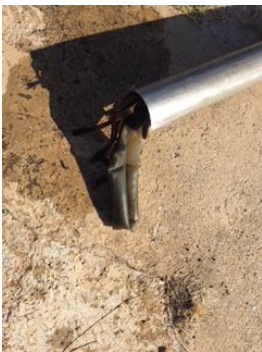
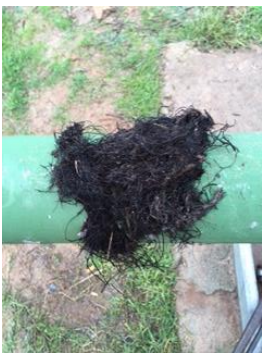
Each borehole was airlifted to clear as much debris from the bottom of the boreholes as possible. The camera logging showed that the boreholes especially those not properly sealed at the surface had all sorts of foreign material ranging e.g. cable ties, conduit piping of varying lengths, fire hose, frogs, snakes, grass, etc. lying on the bottom. The airlifting removed most if not all such material together with varying amounts of sand.

An airlifting exercise effectively removes debris from the bottom of a borehole.

Properly sealing each borehole would eliminate the likelihood of foreign matter entering.

Properly sealing boreholes prevents foreign matter entering.

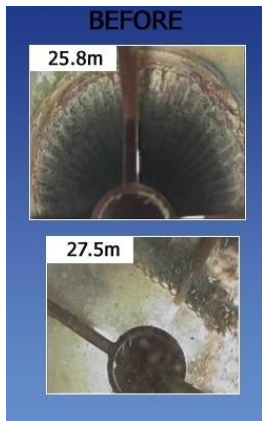
W34001 – Before and after treatment, ATW

The optimum pumping rates for each hole has been determined by comparing the plotted data/curves over time, bearing in mind a high biofouling potential, e.g. a rate of 7 litres/second = ~605 m³/day (7x60 sec x 60 min x 24 hrs). The objective is to achieve as low and as constant a pumping rate as possible. One can plot this recommended rate/value on the base axis (Q Kl/day) of the relevant borehole graph to evaluate how conservative the yield is for the borehole. All recommended yields can be similarly viewed, collectively a total recommended production can be calculated for the wellfield. When the boreholes are retested, initially at 6-

monthly intervals for the first year after regeneration and thereafter annually, the data collected is plotted on the graph to measure whether any change has occurred since the last test performed. If any change is observed, one can determine the extent. If the change indicates a decline, the abstraction rate would need appropriate adjustment whereas little or no change, the initial rate can remain unchanged. Without the ongoing testing and monitoring, there is no way of tracking changes or knowing the extent of changes. The plant requires a team of staff who bring cooperation, commitment, and willingness to learn accountable to the CoCT in meeting its responsibilities to manage these wellfields effectively.

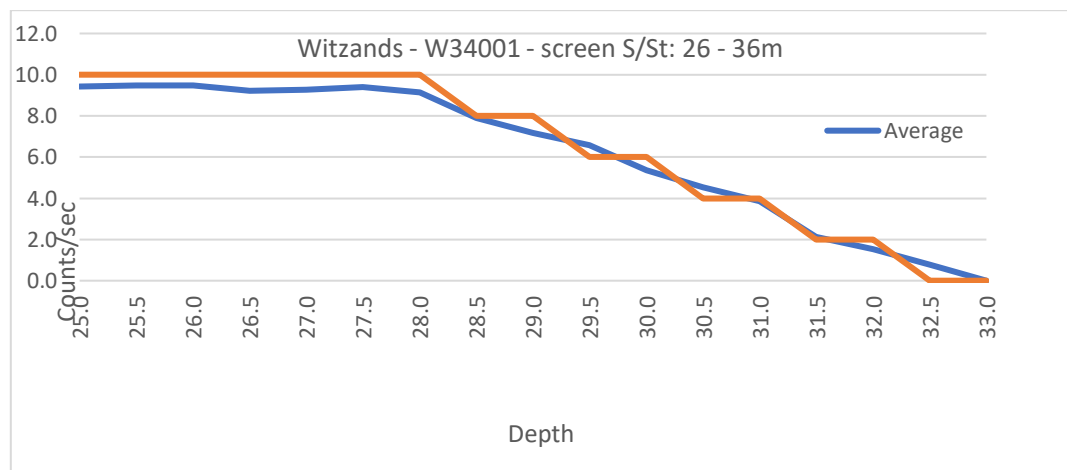
W34001 – this is the best constructed borehole in both Atlantis wellfields. It has 200mm OD PVC casing with a stainless wedge wire screen – 0.5mm opening. The screen is from 26 – 36m i.e. 10m in length. From the graph, it will be observed that flow starts at approximately 32.5m and stops at 28m or 4.5m which means that only 45% of the screened area is productive.

In all 3 cases, the length of the screened section was far longer than it needed to be as the inflow is not across the full screen length. This just means that in any future drilling programme the use of geophysical logging techniques will be vital for the proper placement of the screens which in turn will result in a considerable cost reduction in the overall cost of a borehole. A final consideration to flow meter log all the remaining boreholes would also be practical.

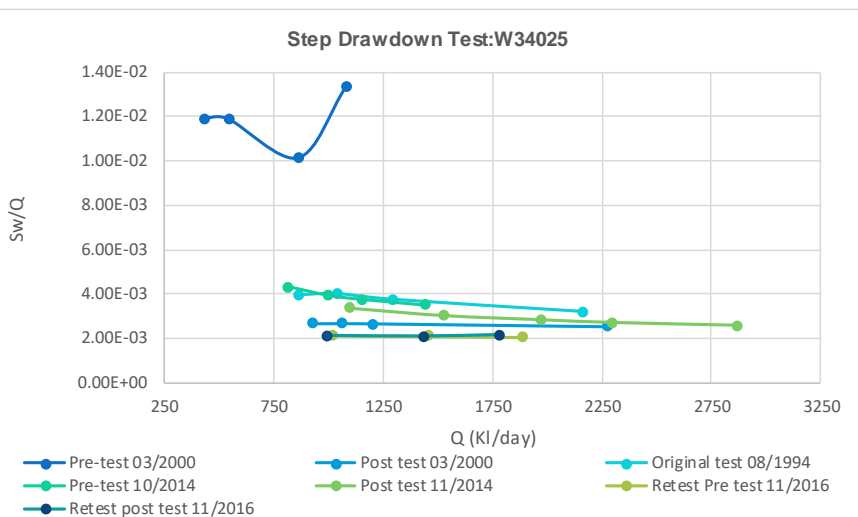
Average Sw/Q: 2.89E-03

Decline(-)/Improve(+) Post-'14 to Pre-Test'14: 26%

Date	SC l/s/m
1994	268.1
2000	84.7
2000	380.2
2014	257.1
2014	346
2016	473.9
2016	473.9

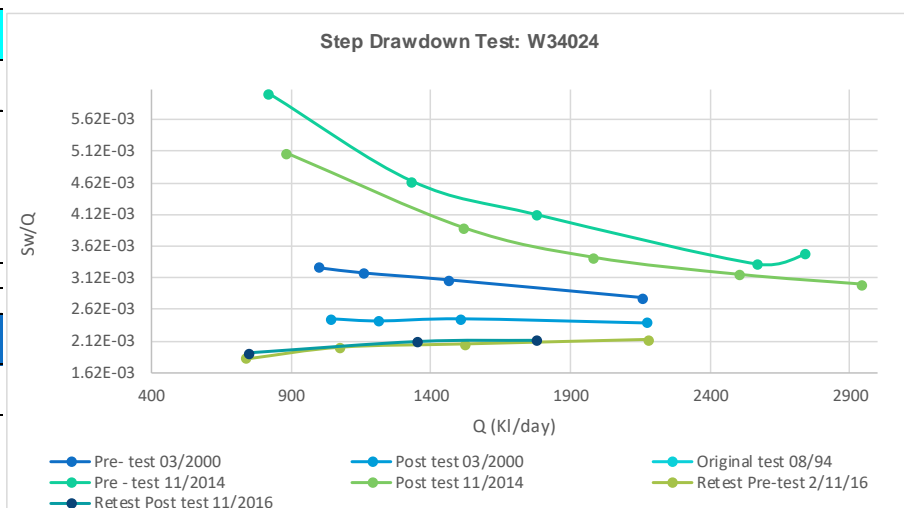
Step No:	Q (l/s)	Q (m³/Day)	Sw (m)	Sw/Q
1	10.25	886	4.51	5.09E-03
2	17.61	1521	5.94	3.91E-03
3	22.96	1984	6.82	3.44E-03
4	29.03	2508	7.94	3.17E-03
5	34.13	2949	8.880	3.01E-03

Average				3.72E-03
Decline(-)/Improve(+) Pre '14 to Post-Test 2014				14%

Date	SC l/s/m
1994	259.1
2000	323.6
2000	408.2
2014	231.5
2014	266.9
2016	495
2016	485.4
