# The Use of Electrical Resistance Testing to Accurately Locate Buried Lead Water Service Lines and Other Pipe Materials Commonly Found in Drinking Water Pipes

## Abstract

This paper discusses how electrical resistance testing can be used to assess drinking water pipes without digging. Using a machine-intelligent technology for assessing pressurized and unpressurized water pipes, electrical resistance technology has emerged as the only known method for identifying one or more pipe materials, including copper, galvanized metal, lead, and plastic pipe, without excavating and removing topsoil. Identified specifically by the US EPA as an emerging technology to locate lead pipes, electrical resistance testing allows a probe to enter, transit, and exit a water pipe with minimal pipe disturbance or customer disruption. This paper also covers the continued risk of lead exposure – including in large diameter asbestos cement pipes with lead soldered joints - and the potential impact of the LCCR on future real estate transactions, which requires sellers to disclose the existence of lead service lines starting after the EPA October 2024 deadline. While lead service lines are under the spotli

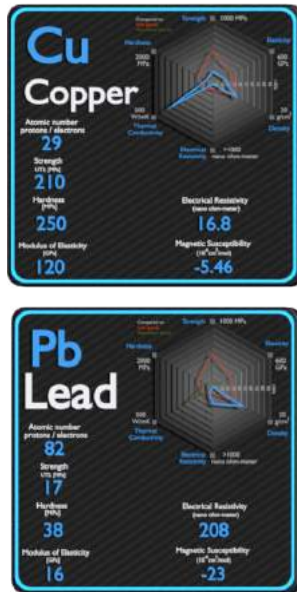
Figure 21. Elements.

As shown in Figure 21 & 22, Copper and Lead both have different resistance levels to electric current, allowing Electro Scan’s SWORDFISH to measure and record the changes as its probe passes through different pipe materials.

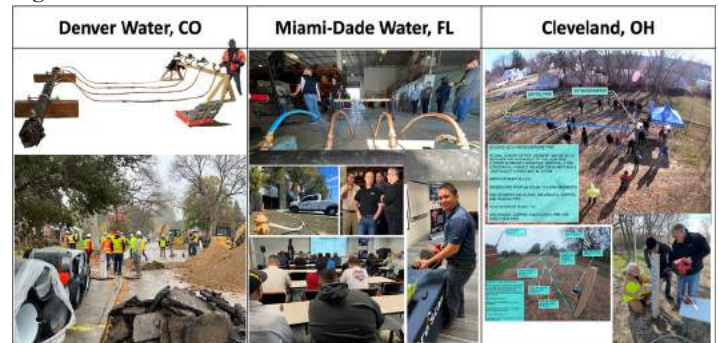
Figure 25. SWORDFISH Benchmark Evaluations

A key factor in SWORDFISH’s success has been its numerous field tests by some of the nation’s largest and smallest utilities. Both aboveground and below ground tests, as illustrated in Figure 25, demonstrated how SWORDFISH can navigate the most challenging underground pipe material changes, in many cases, not known by the utility.

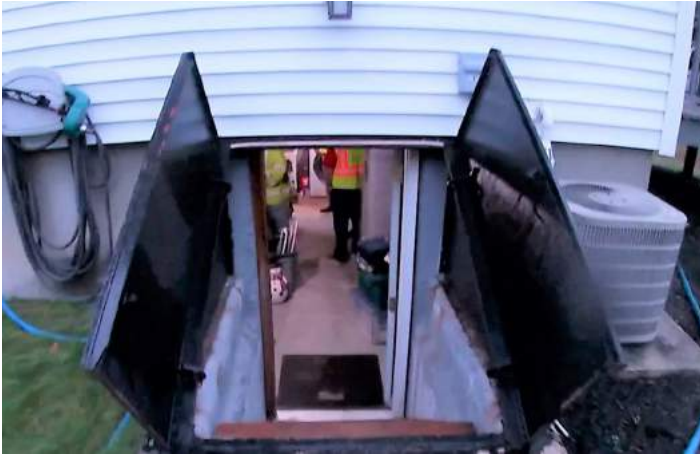
Figure 28. A Basement Entry in Massachusetts.

Electro Scan recommends that all service providers and utilities use a minimum two-person crew to assist in meter location, removal, survey, and clean-up activities, as shown in Figures 28-31.

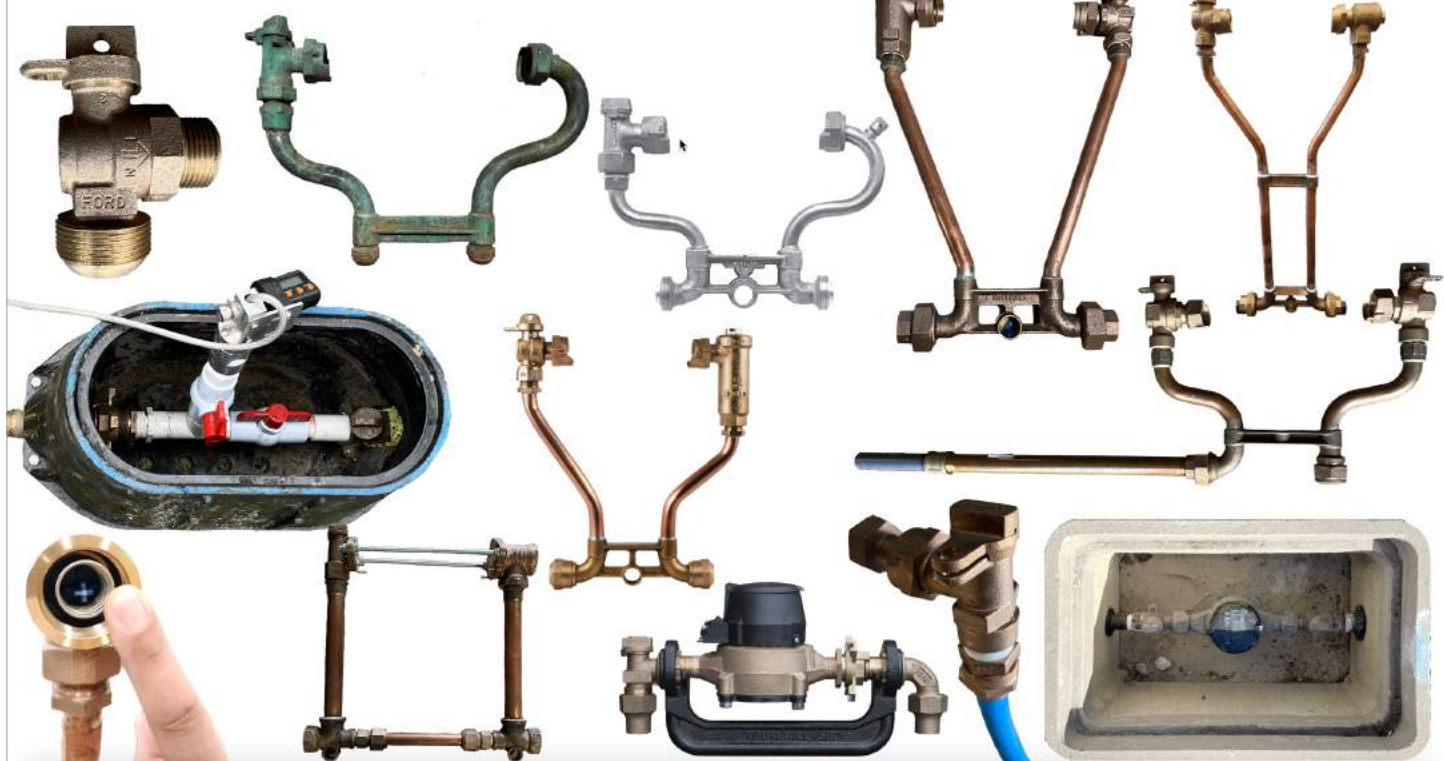
Figure 34. Various Curb Box Meter Settings.

As shown in Figure 34, there are a variety of meter settings used in the water industry. Representing the pipe that supports the meter

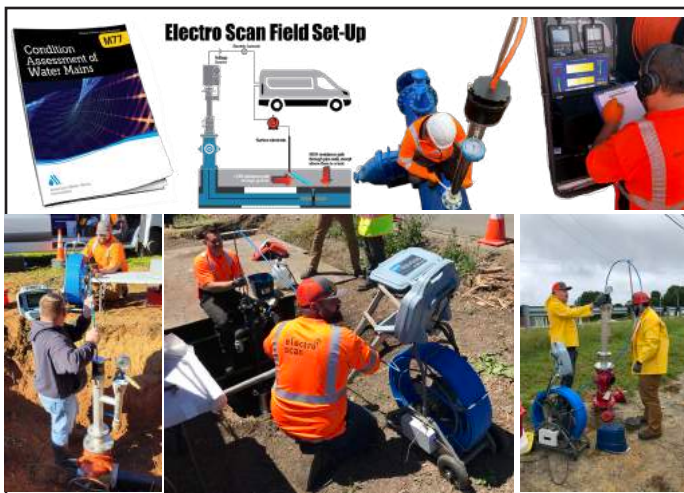
Figure 36. Example Electro Scan Pressurized Pipe Insertions into Live Drinking Water Pipes in Accordance with AWWA M77 Standard (2019).

Adapting its insertion devices approved for larger pipe diameters from 3 inches to 72 inches, included as part of AWWA M77 Standard for Condition Assessment of Water Main,<sup>15</sup> shown in Figure 36, Electro Scan has created a line of insertion tubes for small diameter pipes from 1/2 inch to 3 inches in diameter, shown in Figure 37.

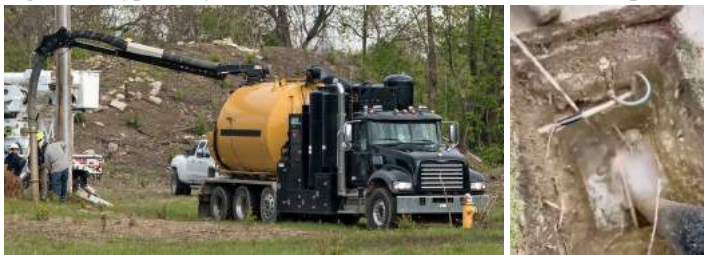
Figure 41. Typical Hydro Excavation Truck Used to Eliminate Topsoil.

As shown in Figure 41, traditional jetting trucks have been re-configured to allow for high pressure nozzles to remove topsoil, sucking up dirt and waste materials into truck mounted tanks for removal.

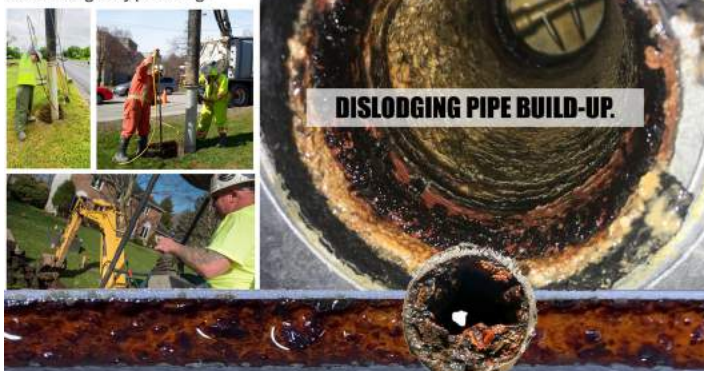
However, as shown in Figure 42, the pressure of hitting external pipes from 1,000 psi to 5,000 psi, can cause dislodging of internal pipe films that could be harmful to customers if consumed.

Build-up of minerals such as brass, calcium, copper, iron, magnesium, lead dislodged by potholing.

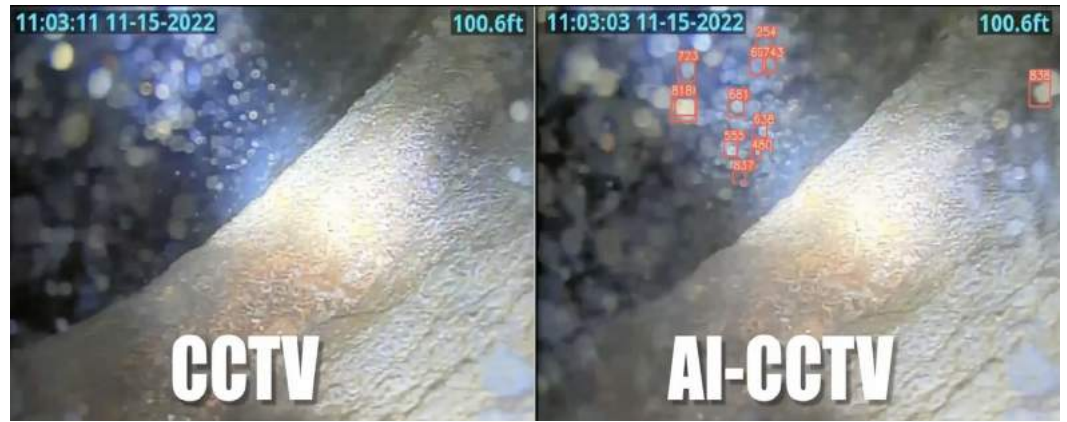
Figure 39. Electro Scan AI Uses High Resolution Cameras to Track and Confirm Leaks Found in Pipes.

Electro Scan has become a leader in studying the movement of particulates in pressurized and non-pressurized pipes. Using high resolution cameras that are positioned at leak locations found by Electro Scan's award-winning technology, operators confirm exit locations by clock position in pipes to pinpoint leak locations, as shown in Figure 39.

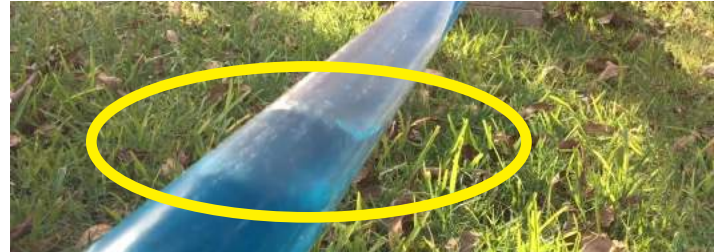
Figure 40. Baseline Disturbance from Re-Energizing Water Services.

Recently, water quality measurements taken **before** SWORDFISH testing (i.e. at pipe stagnation) and **after** SWORDFISH testing (i.e. re-energizing pipe to bring back in-service). As shown in Figure 42, water quality pre- and post-tests show that water quality returned to stagnation levels by the 8th sample draw, without any post-survey pipe flushing as recommended by Electro Scan Inc.

Water hammers are phenomena that can occur in any piping system where valves are used to control the flow of water. A water hammer result from a pressure surge or high-pressure shockwave that propagates through a piping system when a fluid in motion is forced to change direction or stop abruptly, as shown in Figure 40.

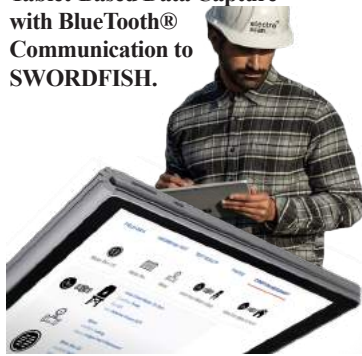
Figure 44 Microsoft Surface Tablet-Based Data Capture with BlueTooth® Communication to SWORDFISH.

Developed and successfully implemented worldwide, Electro Scan's data management and reporting allows field data capture and office reporting within minutes of completing each SWORDFISH survey. Data from all SWORDFISH handtools is transmitted to a Microsoft Surface Tablet, included with all sales and to all authorized service providers. Data is displayed in real-time for the operator to see readings as each survey takes place.

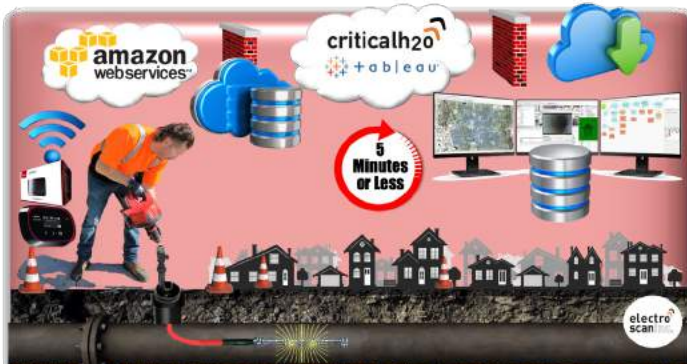
Figure 45. Electro Scan's AWS CriticalH2O Cloud Configuration.

Initial address data entry, GPS location, photographs, and condition assessment are recorded and transmitted, directly to the Electro Scan Cloud as shown in Figure 45 & 46, with reports generated as shown in Figure 42.
