# Hydroflow Case Study Site - Victoria & Alfred Waterfront bioCURE (PTY) LTD Distributor to Hydroflow SA

#### Introduction:

The Victoria & Alfred Waterfront, located in Cape Town, South Africa, is a premier mixed-use development and one of the most popular tourist attractions in the country. They use sea water from the Table Bay Harbor for their Heat Exchangers.

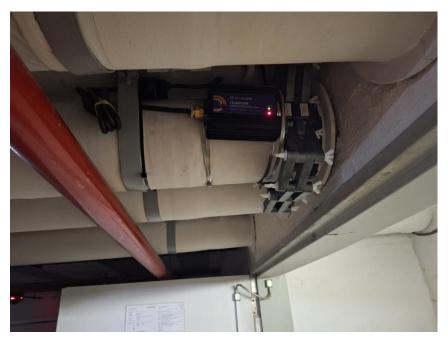
A Hydroflow I Custom unit was installed in November 2023 on one of the two 200mm diameter pipelines leading to Heat Exchanger 4 for a 6-month trial. Heat exchanger 4 draws water from a 280mm diameter pipe, seaside, which then splits after the pump and filters to two x 200mm pipes that join in a manifold and feeds a 280mm pipe to the heat exchanger.

For trial purposes, we installed the Hydroflow unit between the heat exchanger and the sea water pump and filter packs.

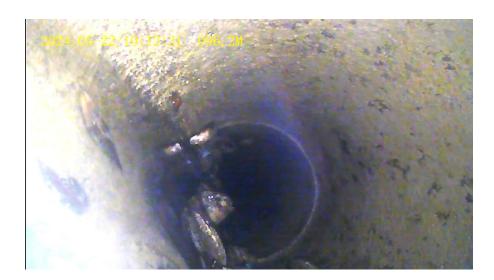
## Camera Inspection of line six months later:

The period during which the Hydroflow unit was installed and evident from camera footage the following observations were made:

- Large amounts of sea life and chunks of mussels released from pipe surface after two weeks
- No new sea life formed within the pipeline, there are only a few mussels stuck in the line, and will loosen over time
- Heat exchanger cleaner on back wash when cleaned by operators
- After initial discharge, minimal sea life found in filters during cleaning regime
- Downtime of unit reduced, unit has run continuously throughout the trial period, which is unusual
- Improved efficiency of the heat exchanger due to higher flows
