# Water Main Break Rates In the USA and Canada: A Comprehensive Study

An Asset Management Planning Tool for Water Utilities

Utah State University  
Buried Structures Laboratory  
Steven Folkman, Ph.D., P.E.

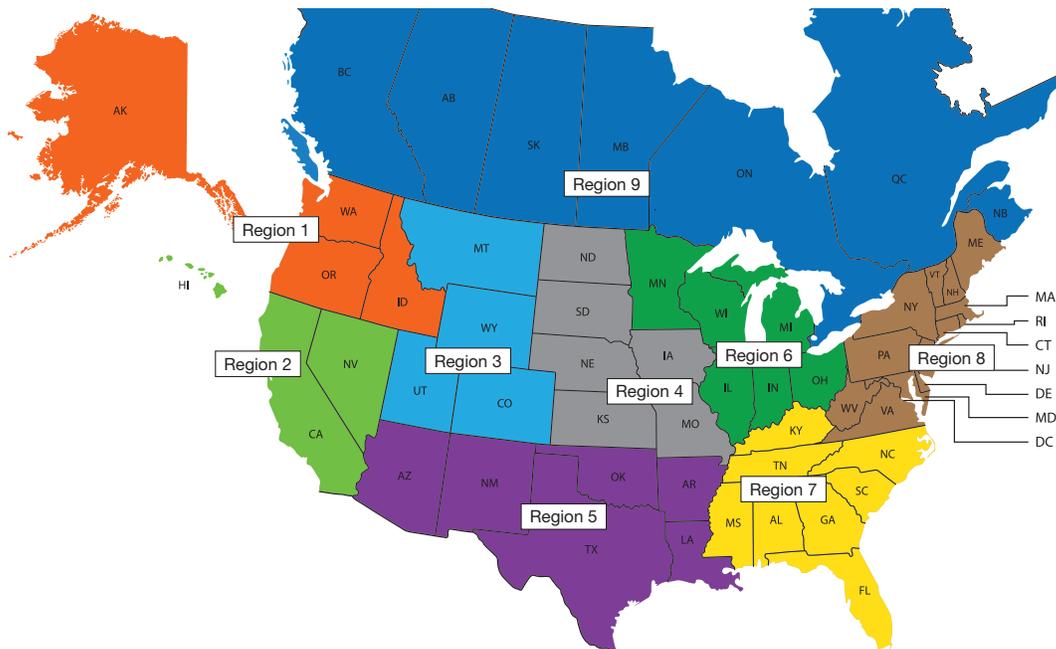
**FIGURE 11: REGIONAL PERCENTAGE OF LENGTH OF PIPE BY MATERIAL TYPE (BASIC SURVEY)**

Figure 11 illustrates the regional distribution of pipe material usage as a percentage of the total length in that region. It is interesting to note the significant differences in regional pipe material utilization. Cast iron (CI) and ductile iron (DI) pipe represent approximately 86% of the water mains in Region 6 and over 75% in Regions 4, 7, and 8. PVC has a leading role in Regions 3, 5 and 9 and is slightly behind asbestos cement (AC) pipe in Region 2. AC pipe has a significant presence in Regions 2 and 5. Region 2 is unique in that it is the only region where AC pipe is the most common material. This suggests that the selection and use of pipe materials are based on historical preference versus comparative cost analysis or environmental conditions. Since CI and AC pipes are no longer manufactured in the US and Canada, the use of these materials in water systems should be decreasing with time as they are replaced. By applying asset management best practices, life cycle cost analysis should be used to do a comparative total cost of ownership evaluation of what pipe material should replace the CI and AC pipes.

Water main pipe material usage varies significantly over geographic regions (see Figure 11). This suggests that the selection and use of pipe materials are based on historical preference versus comparative cost analysis or environmental conditions. The upper northwest and eastern half of the USA (Regions 1, 4, 6, 7, and 8 as illustrated in Figure 1) have either cast iron or ductile iron pipe for much of the installed pipe length. Regions 3, 5, and 9 have more PVC pipe than any other material. The most common pipe material in Region 2 is asbestos cement and it is unique in that respect.

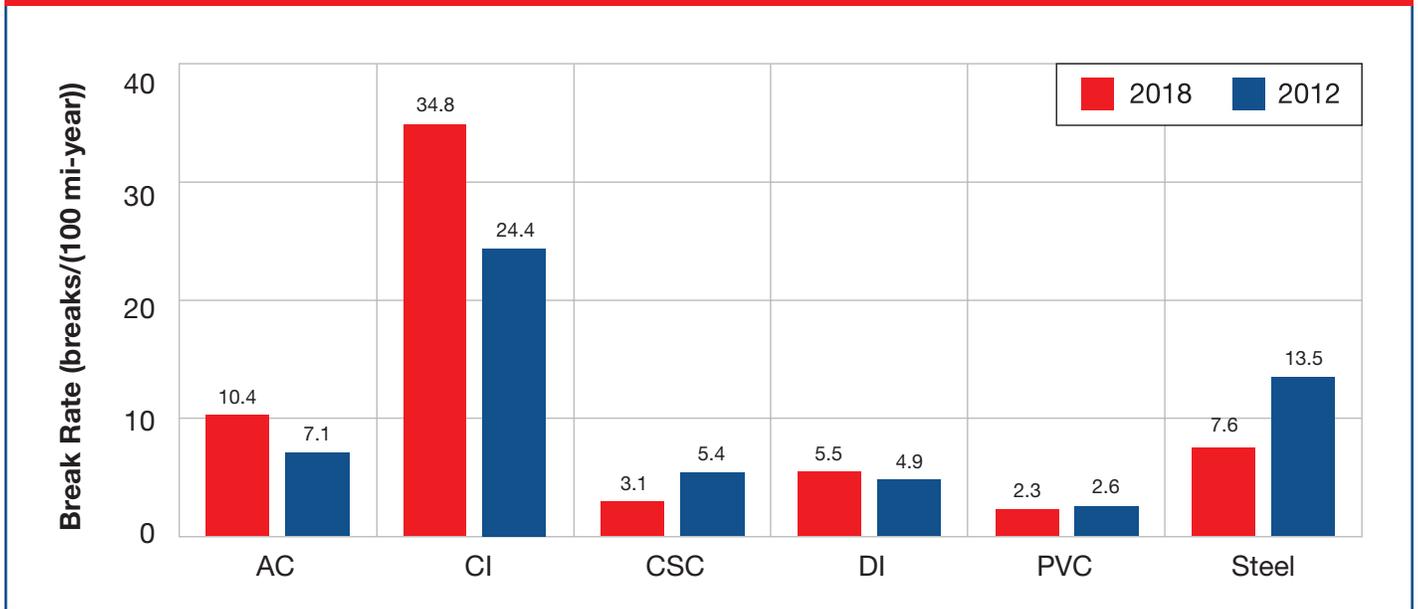
**FIGURE 22: COMPARISON OF BREAK RATES OF THE 2018 AND 2012 SURVEYS**

Figure 22 compares the break rates of the 2012 and 2018 surveys. Since over 90% of installed pipe consists of AC, CI, DI, and PVC, the break rates for those material types will be most accurate. From 2012 to 2018, Figure 22 shows a small decrease in break rates for PVC and a small increase for DI pipe. The overall consistency of those values demonstrates they are accurate. Again, the increase in break rates for AC and CI pipes is a very significant observation.

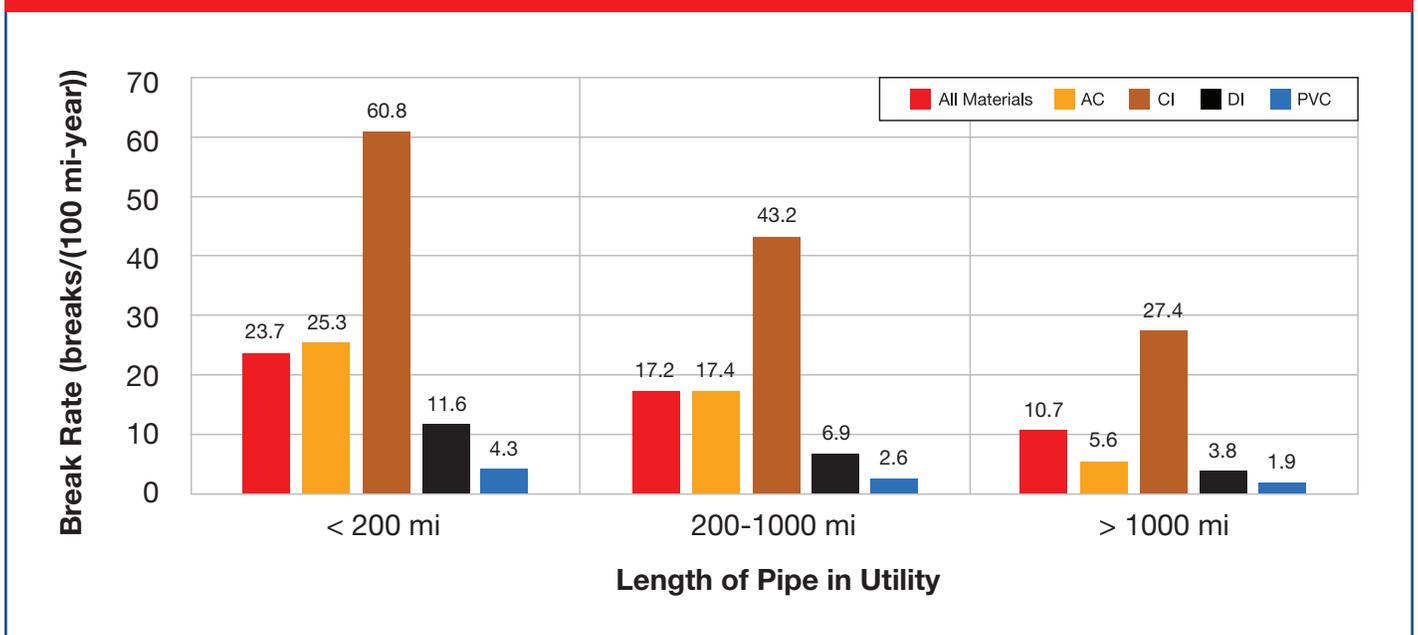
**FIGURE 23: BREAK RATES BY UTILITY SIZE FROM THE BASIC SURVEY**

The size of a utility can affect break rates. Three sizes of utilities are considered here based on the length of pipe; small with less than 200 miles, intermediate with 200 to 1000 miles, and large with over 1000 miles. Figure 23 illustrates the overall break rate (for all pipe materials) and then separated by the four most common pipe materials in these three utility sizes. The large utilities consistently had lower break rates than intermediate and smaller utilities. This is likely due to better funding and larger staffs for engineering design, monitoring and information gathering, installation oversight, and repair of water mains. It is very significant that small utilities consistently have break rates at least double that of a large utility.

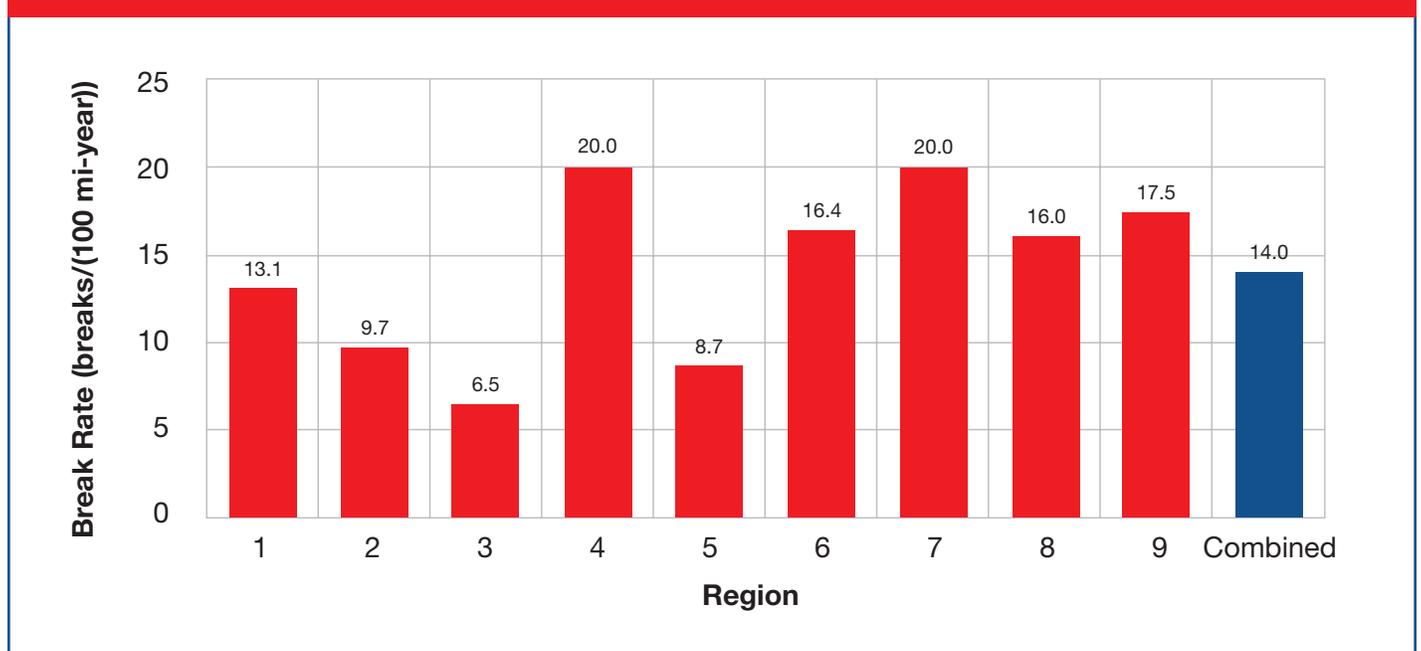
**FIGURE 24: OVERALL BREAK RATES BY REGION FROM THE BASIC SURVEY**

Figure 24 illustrates the overall break rate broken down by region. Clearly not all regions are experiencing the same failure rate. In Table 1, the number of respondents for each region is reported. It was desired to separate US and Canadian break rate data. This is illustrated in Figure 25. Canada can have very corrosive soils (Seargeant, 2013) and this is reflected in the high break rates of cast and ductile iron pipes in Figure 25. Seargeant reported that the highly corrosive soil in Edmonton necessitated a transition from cast iron to asbestos cement pipes in 1966 and then to PVC starting in 1977. The transition to PVC has produced a dramatic reduction in water main break rates for the city.

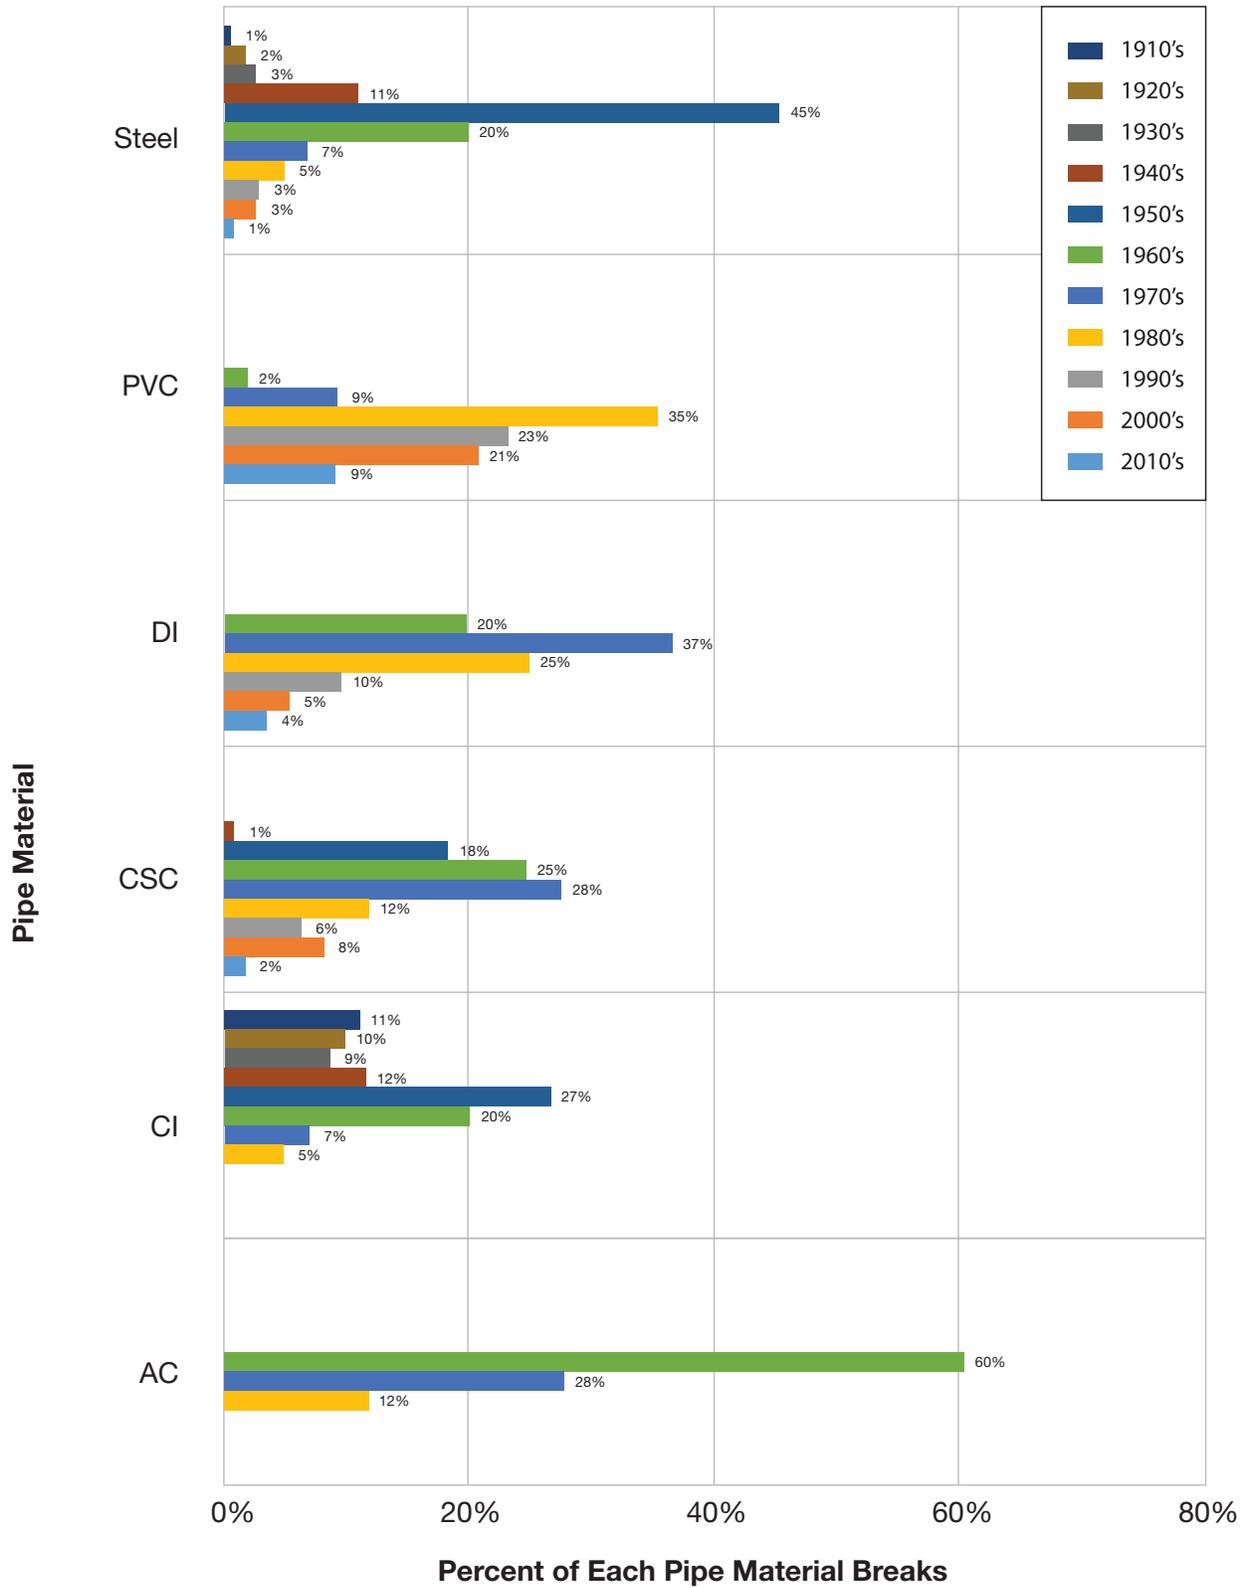
**FIGURE 26: PERCENT OF FAILURES PER DECADE OF INSTALLED PIPE MATERIAL**

The basic survey asked respondents to break down the failures into the decade when they were installed. Some of the respondents did not know the age of the failed pipes and they were not included in the results. Figure 26 illustrates the percentage of failures of each pipe material based on the decade of installation. For example, asbestos cement (AC) pipe had 60% of the breaks from pipe installed in the 1960's, 28% in the 1970's, and 12% of the breaks in pipes installed in the 1980's. Note that the largest percentage of failures is usually not in the oldest pipes (AC being an exception), which has several possible causes. One important cause is the amount of pipe present in a given age range. As the older pipe is replaced there is less available to fail. Also, cast iron and ductile pipe wall thickness has decreased over the years which can affect time to failure. The results in Figure 26 are also related to when a pipe material was introduced or removed from the market. AC pipe has not been installed in the USA and Canada in the past 25 years, and thus, all AC pipe failures date from the 1980's and earlier. Little cast iron pipe has been installed since the 1980's and that is reflected in Figure 26. Widespread ductile iron and PVC pipe production in the USA did not start until about 1970, so we should expect to see a small failure percentage for both DI and PVC installed in the 1960's and none in the 1950's and earlier.

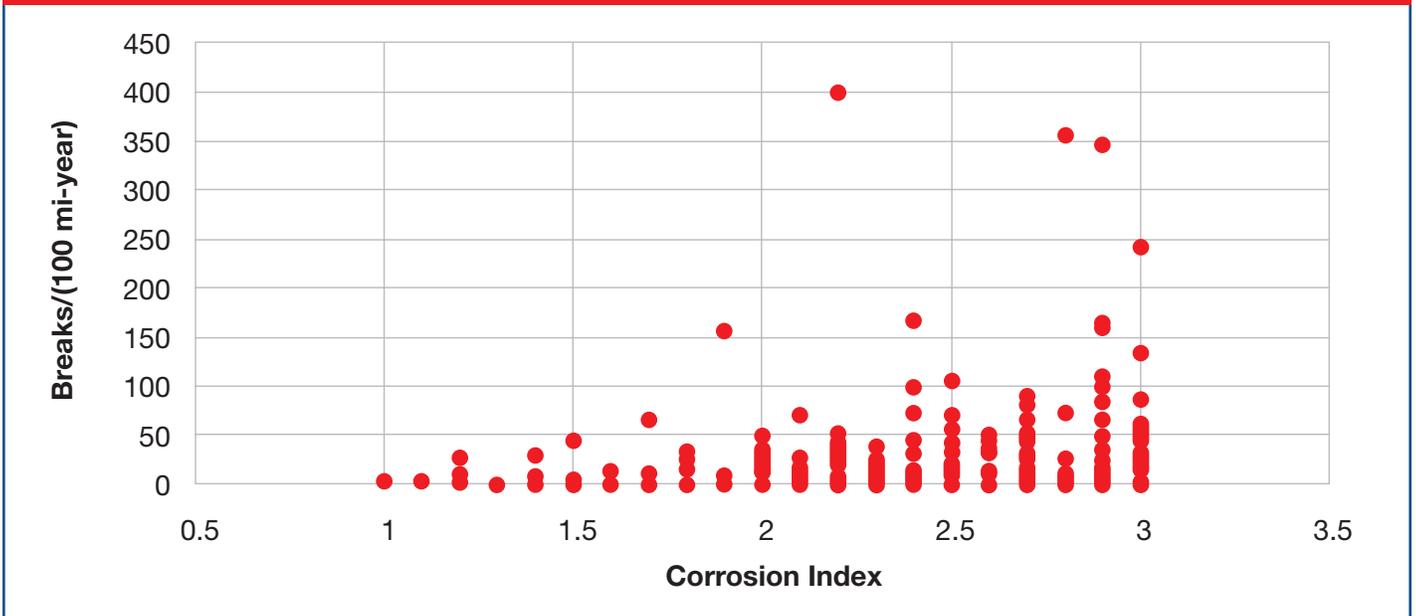
**FIGURE 33: INDIVIDUAL UTILITY BREAK RATES FOR CAST IRON PIPE VERSUS THEIR CORROSION INDEX**

It is reasonable to expect break rates would increase when pipe is installed in corrosive soils. To examine this, plots were made of a utility's corrosion index versus break rate. Figure 33 illustrates this for cast iron pipe. There is a trend of higher break rates with increasing corrosion index, but the wide scatter in the data makes analysis difficult. The high break rates in Figure 33 are associated with small utilities that have a small amount of pipe. Consider a utility with 1 mile of cast iron pipe with 2 breaks during the past year. That would translate to a break rate of 200 breaks/(100 miles)/year. If that utility had no breaks the following year, the break rates drop to zero.

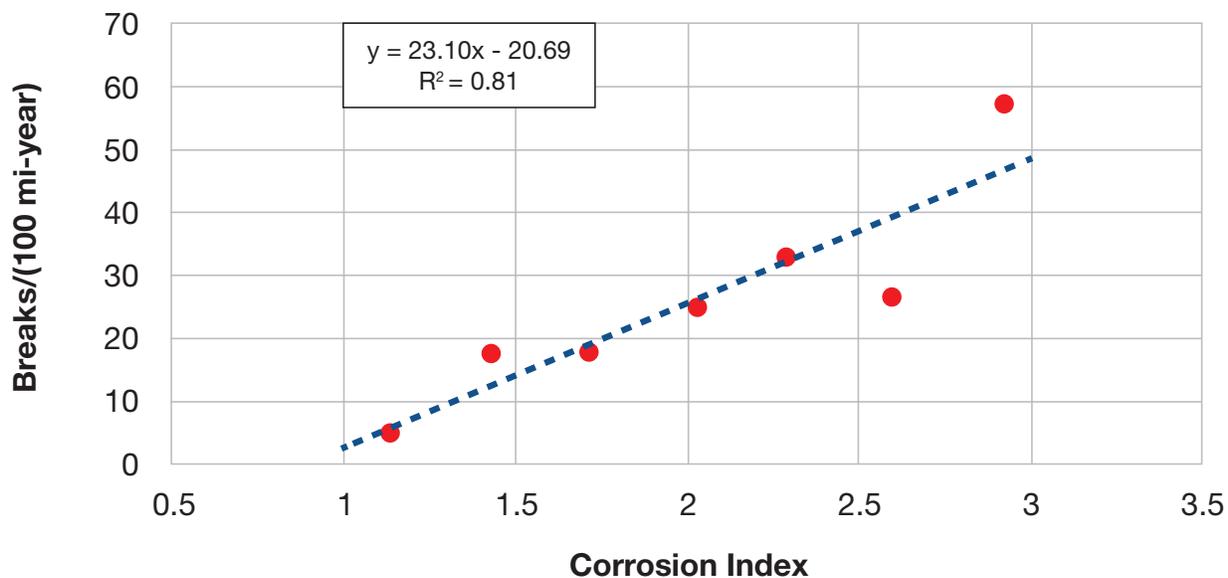
**FIGURE 34: CAST IRON PIPE BREAK RATE VERSUS CORROSION INDEX**

To get a realistic estimate of break rates, we need to add the number of breaks of a pipe type from several utilities and divide by the sum of the length of that pipe type to compute break rates. The corrosion index data was broken down into the same seven categories used in Figure 32. The results are listed in Table 7. The break rates versus corrosion index data are plotted in Figure 34 for cast iron pipe and Figure 35 for ductile iron pipe. The figures also contain a regression equation fit and a correlation coefficient. Correlation coefficients close to 1.0 indicates an excellent correlation and zero indicate no correlation. Both cast and ductile iron results in reasonably good fits to the data.

Analyses of soil corrosivity completed in this study shows that a cast iron (CI) pipe in highly corrosive soil is expected to have over 20 times the break rate of a CI pipe in low corrosive soil. Traditionally, the thickness of the iron pipe wall provided the additional corrosion protection. CI pipes manufactured after World War II have significantly higher failure rates due to thinner walls. The resulting higher main

Using the equations in Figure 34 with  $x=1$  for a low corrosion risk and  $x=3$  for a high corrosion risk, one can show that a cast iron pipe in a high corrosion soil is expected to have over 20 times the break rate of one in a low corrosion soil. Similarly, ductile iron pipe in a high corrosion soil has over 10 times the break rate than one in a low corrosion soil. Very poor correlations were found for the other material types in this survey.

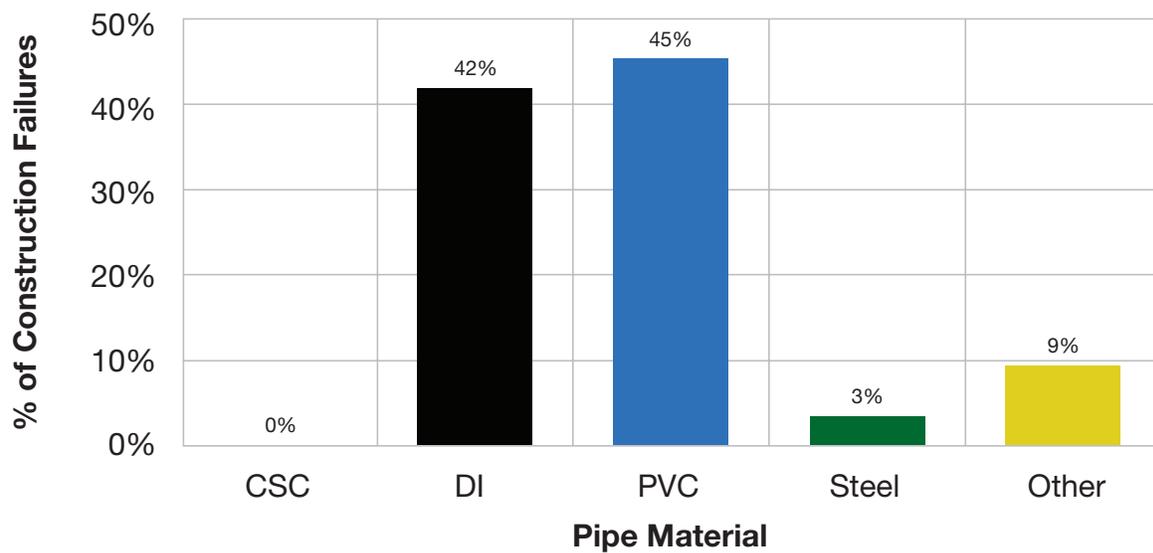
**FIGURE 36: PERCENT OF TOTAL REPORTED CONSTRUCTION RELATED FAILURES FROM THE DETAILED SURVEY**

The detailed survey asked respondents to report failures related to construction activities. Figure 36 illustrates the percentage of total construction failure related to a particular pipe material. Ductile iron and PVC pipes have the majority of construction related failures at a nearly equal frequency. Figure 14 shows that DI and PVC are the two pipe materials that are also most commonly being installed today. This points to the need to improve construction practices for underground infrastructure regarding installation, location services and inspection.

The detailed survey asked utilities to report the number of failures related to construction activities and identify the pipe material that failed. The vast majority of construction related failures involved either ductile iron (DI) or PVC pipe and the number of failures for each material was essentially identical. Therefore, DI and PVC pipe have an equivalent rate of construction related failures. This points to the need to improve construction practices for underground infrastructure regarding installation, location services and inspection.
