WATER WELL JOURNAL

Rehabilitating Jordan's Phosphate Mines

WellJet revitalized 21 wells for one of the country's major industries.

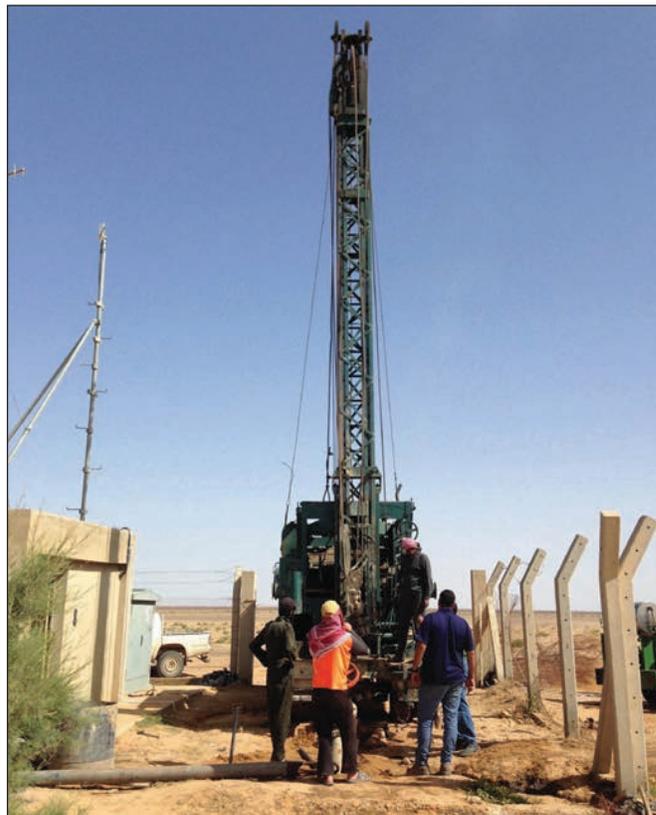
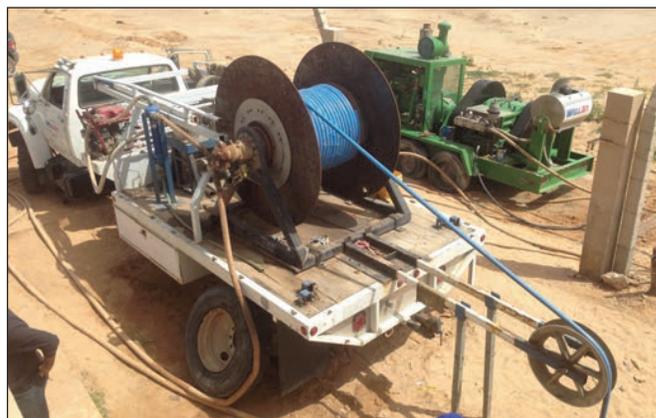
WellJet operations at the Eshidiya Mine Wellfield in Jordan. The mine is for phosphates, one of the leading exports of Jordan.

The patented WellJet uses highly pressurized water in a laminar flow to remove encrustation inside the well casing, open plugged perforations, and penetrate into the gravel pack to break up deposits impeding water flow.

With the combination of pressures from 15,000 to 20,000 pounds per square inch and the ability to maintain that pressure 1000 to 2000 feet below ground, the WellJet tool solves both of those problems.
