A Workable, Lasting Solution for Water Losses through Leaking Water Pipes

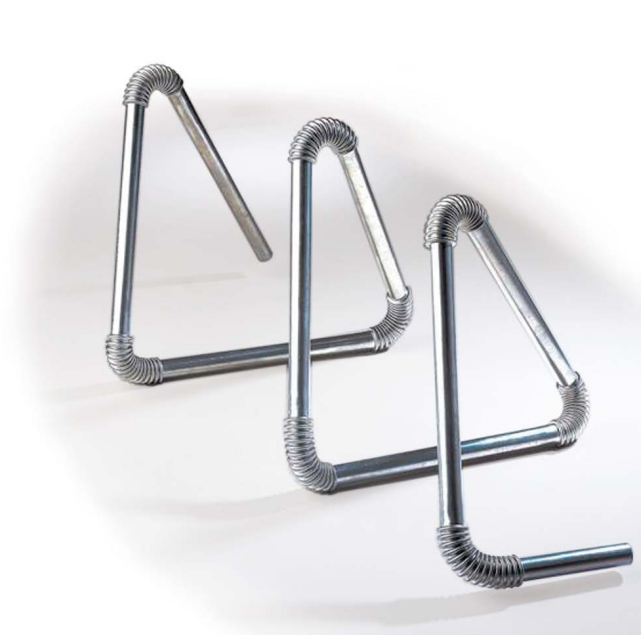
Corrugated stainless steel pipes.

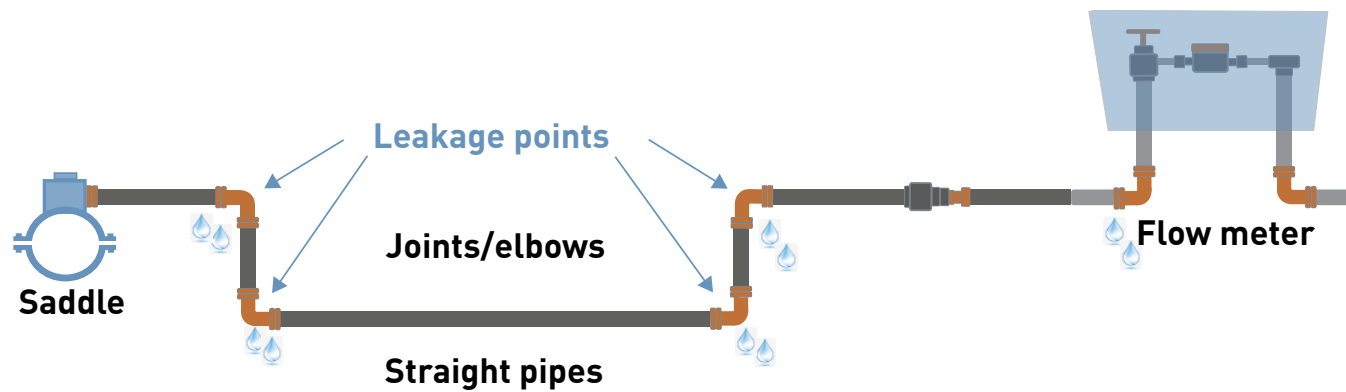
Traditional Piping System

A flexible stainless steel corrugated piping system:

- avoids leaking at joints
- reduces the number of joints
- resists seismic shocks

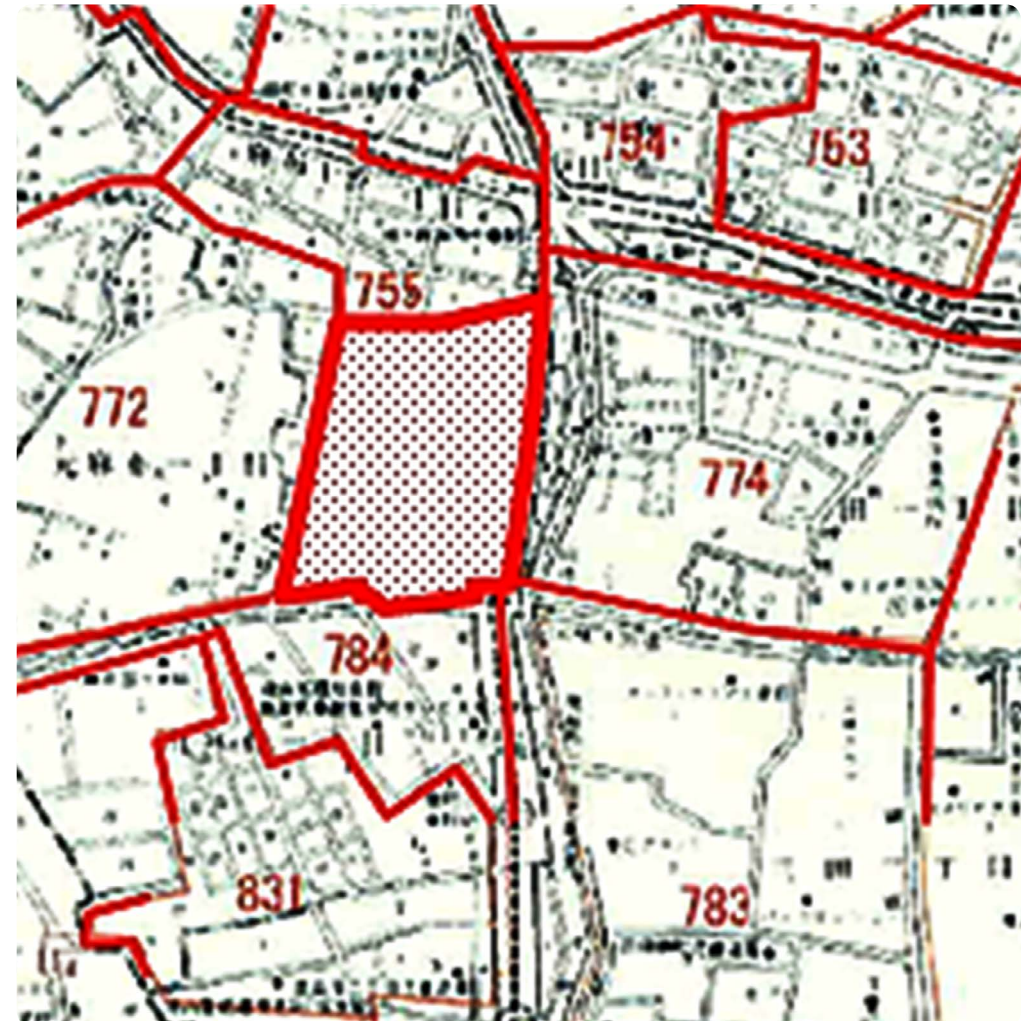
Example of how Tokyo is divided into grid blocks to plan the regular detection of leaks

- Each service area is divided into grid blocks
- Each block is investigated systematically for leaks

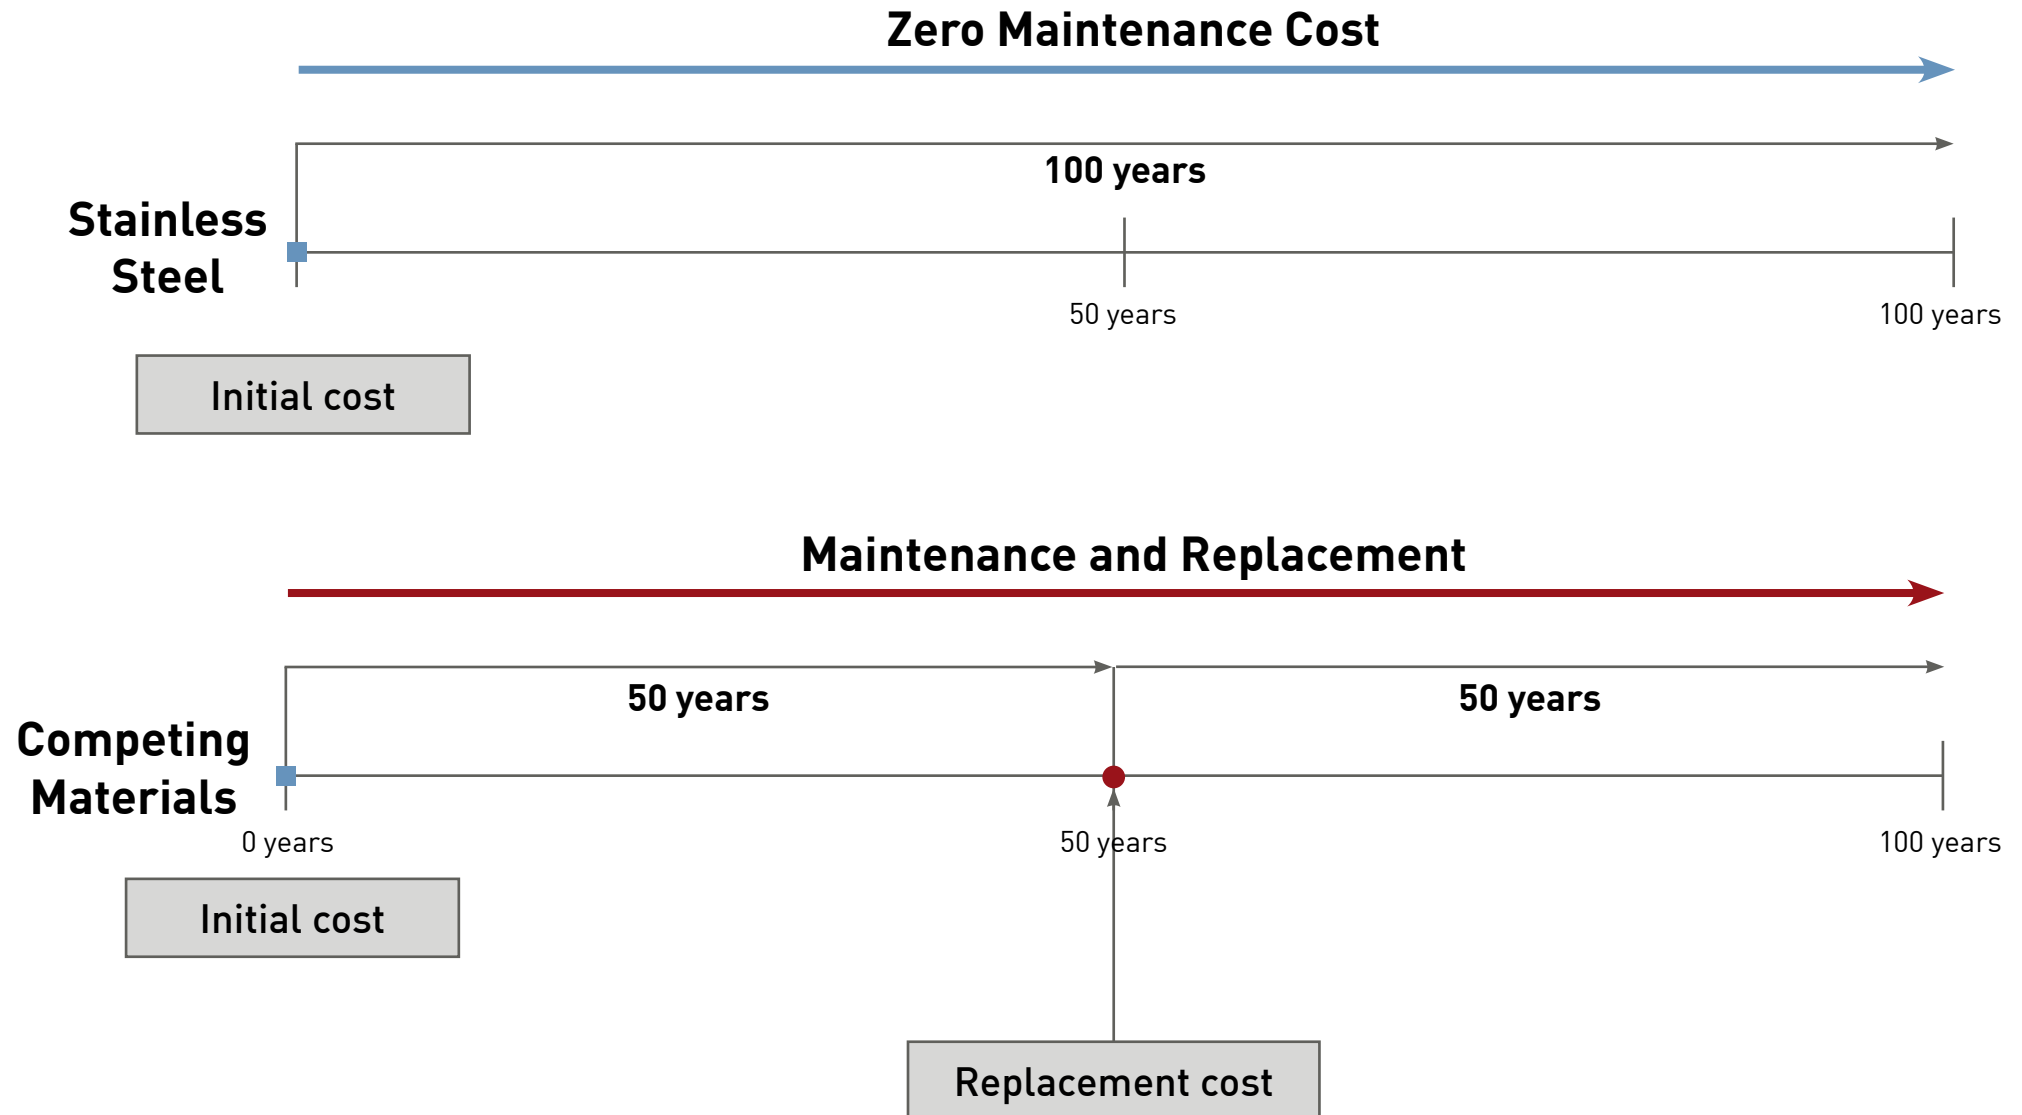
Cost diagram for each material

Duration	Stainless Steel	PVC	PE
100 years	\$1,932	\$3,321	\$3,279

The analysis of the Life Cycle Cost for grade 316 stainless steel illustrates that it is a less expensive product when viewed over its useful life.

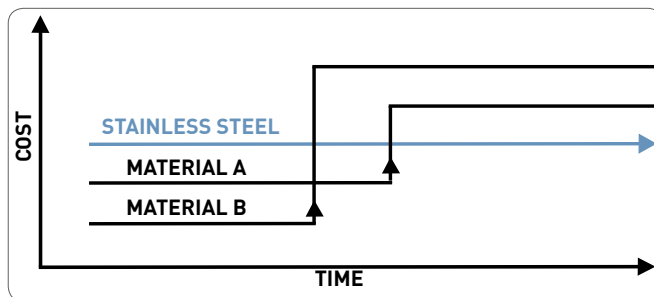
Schematic representation showing the cost of alternate materials A and B substantially increases over time while the cost of stainless steel remains constant.

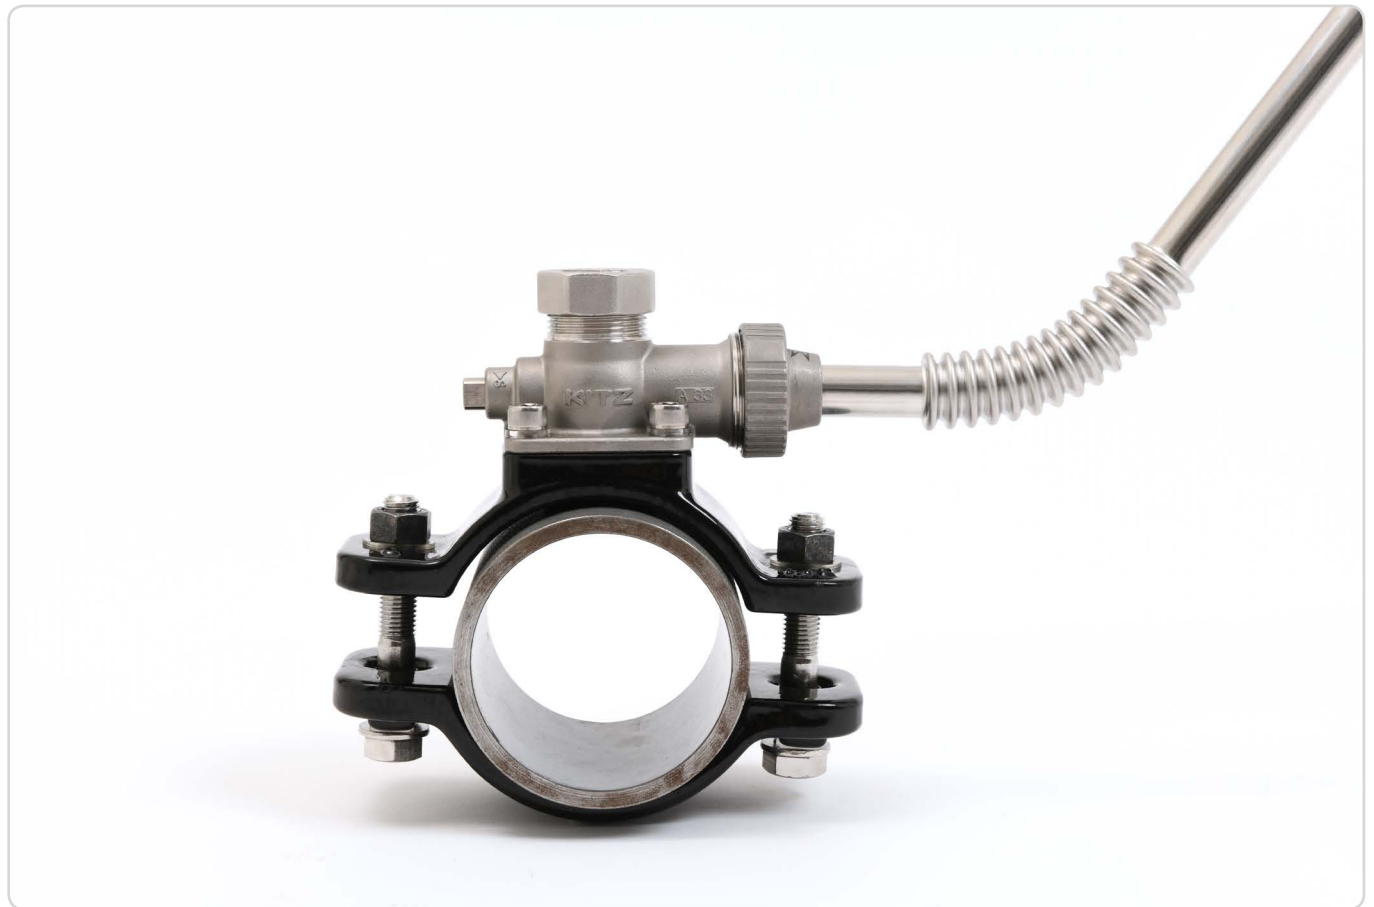
*Saddle used with the stainless steel corrugated pipe system
Photographer: Philippe De Putter*

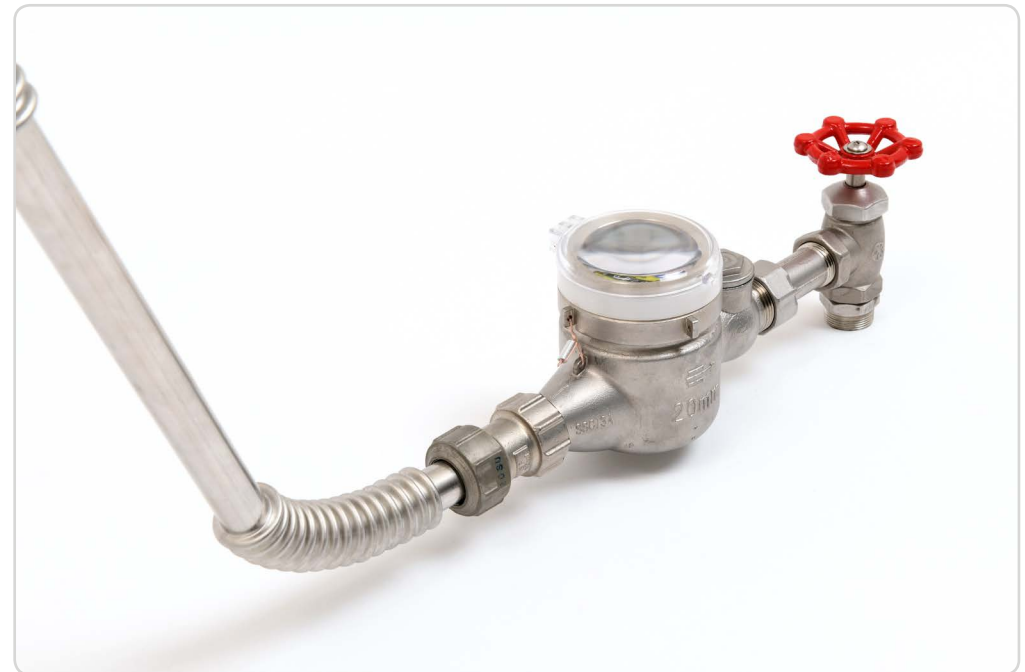
*Flow meter and stopcock with the stainless steel corrugated pipe system
Photographer: Philippe De Putter*

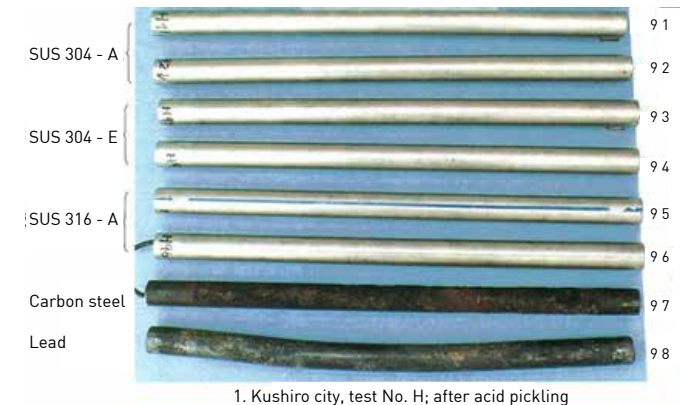
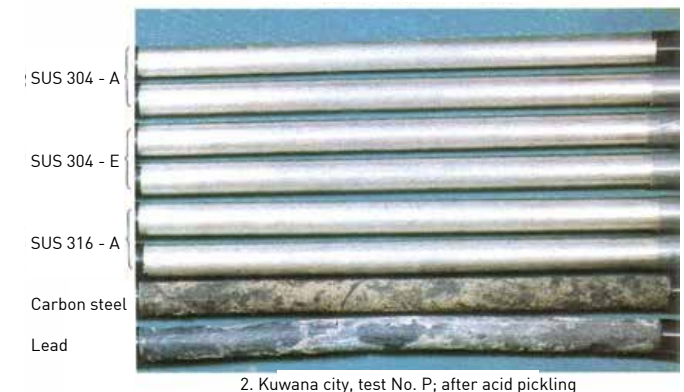
Photos of the burial test results after 10 years of burial in Kushiro (North-East Japan) and Kuwana (Central Japan).

To check the corrosion behaviour of the pipes and to collect data on their corrosion resistance, the Tokyo Water Board commissioned tests using pipes made from a number of competing products, by burying them underground at 10 different sites, for a period of 10 years. The tests showed that stainless steel had performed better in terms of strength and corrosion resistance with grade 316 performing better than 304. The Cl^- and SO_4^{2-} concentrations in the soil were very high. The tests showed no evidence of pitting corrosion on the 316 samples. 316 is a higher alloyed grade and therefore more expensive than 304, but the Tokyo Water Board decided that the greater cost is the cost of laying the pipes and that the risk of failure could not be tolerated because of a potential water shortage. As a result, the decision to specify the stronger of the two grades of stainless steel irrespective of the initial costs difference, was economically justifiable.

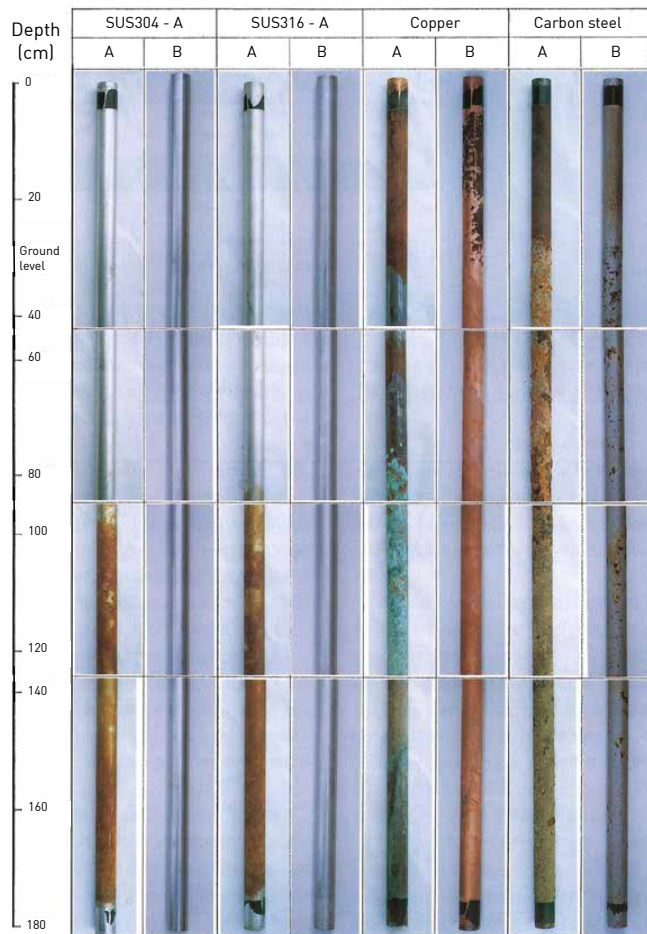
Burial test result from Okinawa.

A: After water cleaning

B: After pickling

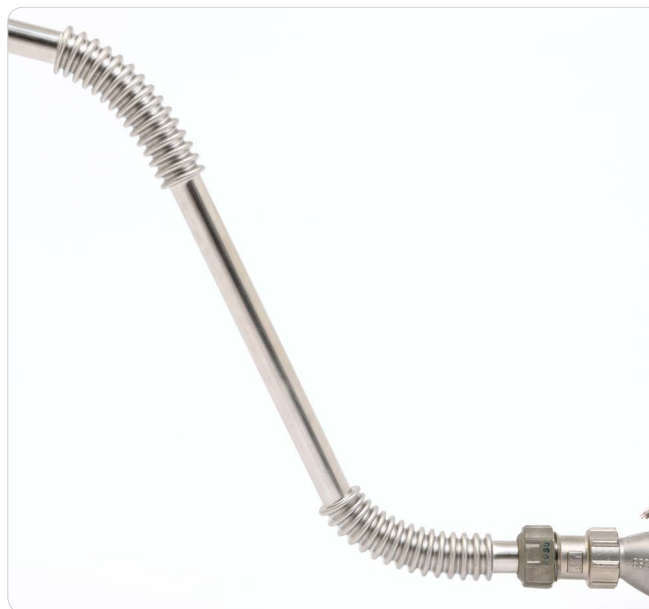
Stainless Steel Corrugated Pipe
Photographer: Philippe De Putter

The Tokyo Water Board discovered that many of their leaks had occurred at joints. The use of corrugated pipes allowed the installers to bend the pipes to the required shapes, thus reducing the need for joints and elbows, but it also allowed the pipes to remain more flexible after installation, and therefore more capable of resisting seismic shocks.

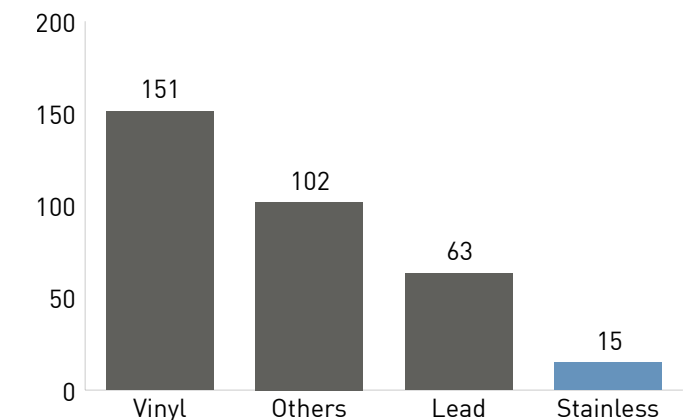
Number of damages after the Great Earthquake of 2011 per pipe material.

City lies on the boundary between the areas demarcated as having a strong to very strong impact (the earthquake was felt as far away as Beijing). After this incident inspections revealed that only 5% of the stainless steel pipes which had been installed were damaged.

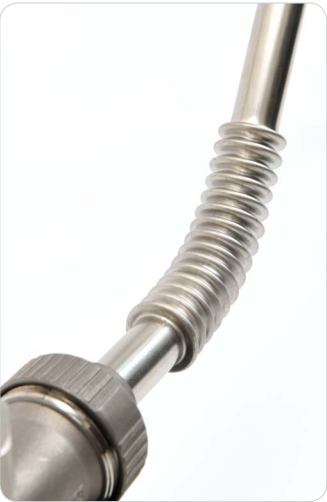
Stainless Steel Corrugated Pipe
Photographer: Philippe De Putter

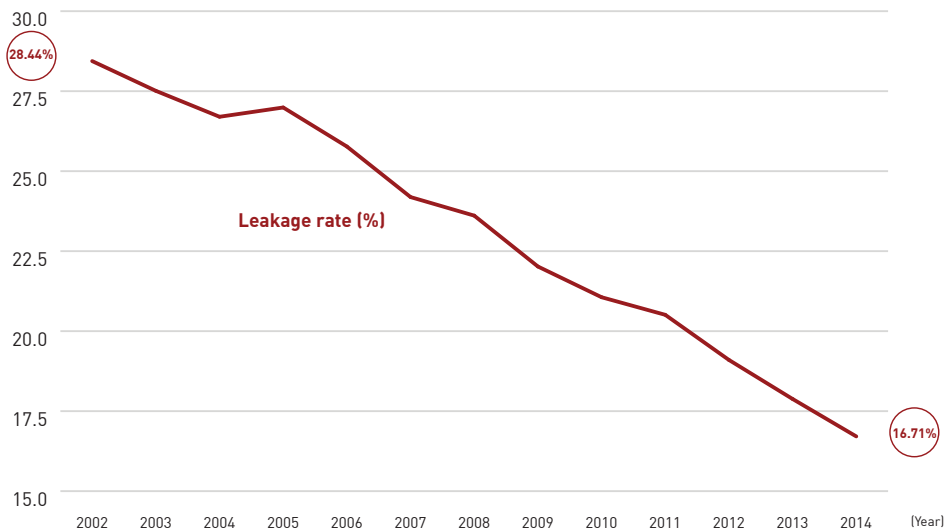
Reduction of leakage

Even though only 35% of the pipes have been replaced so far, an excellent result already became apparent during the 2014 drought. That year had 13% less rainfall than during the previous drought in 2002, but there was no interruption to the water supply, thanks to the vast improvement in the leakage rates. With the leakage rates reduced by more than 10% already, the water savings have been 1.79 billion m³ per year. Water losses were at 365 million m³ in 2005 and were down to 219 million m³ in 2014. The target leakage rate of 10% should be reached by 2025.

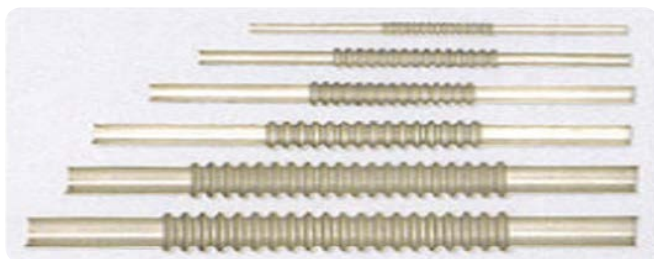
Corrugated stainless steel pipes in different diameters

Standard length: 4 meter
 Maximum length: 5 meter
 Diameter: 15~50 mm for service pipes
 Thickness: 0.8~1.2 mm
 Steel grade: SUS 304 or 316

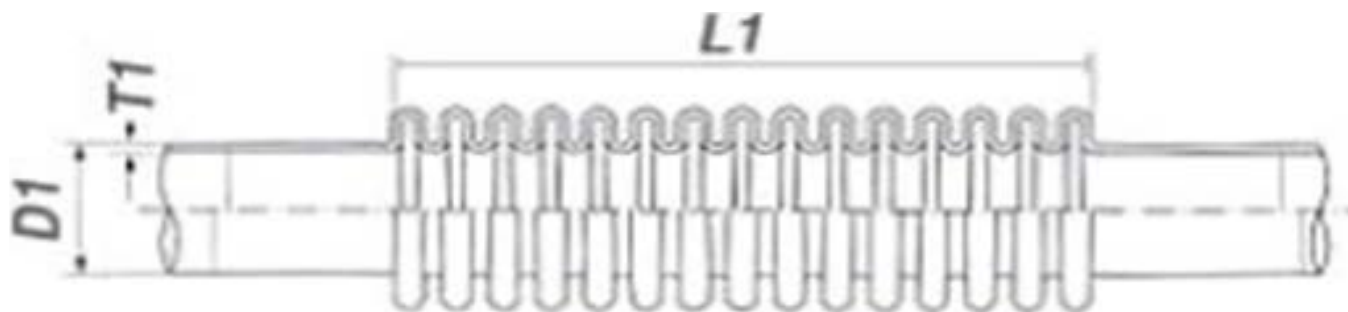
Drawing of a corrugated pipe. D1 is the diameter, T1 the thickness and L1 the length of the corrugation. Specifications for the different diameter pipes can be found in the table.

Name	Outer diameter (D1)		Thickness (T1)		Length (L1)		# of thread
	Standard	Tolerance	Standard	Tolerance	Standard	Tolerance	
13 Su	15.88	0~0.37	0.8	±0.08	80	± 10	15
20 Su	22.22		1	±0.1	120		
25 Su	28.58						
30 Su	34	± 0.34	1.2	±0.12	153	± 20	20
40 Su	42.7	± 0.43			225		
50 Su	48.6	± 0.49

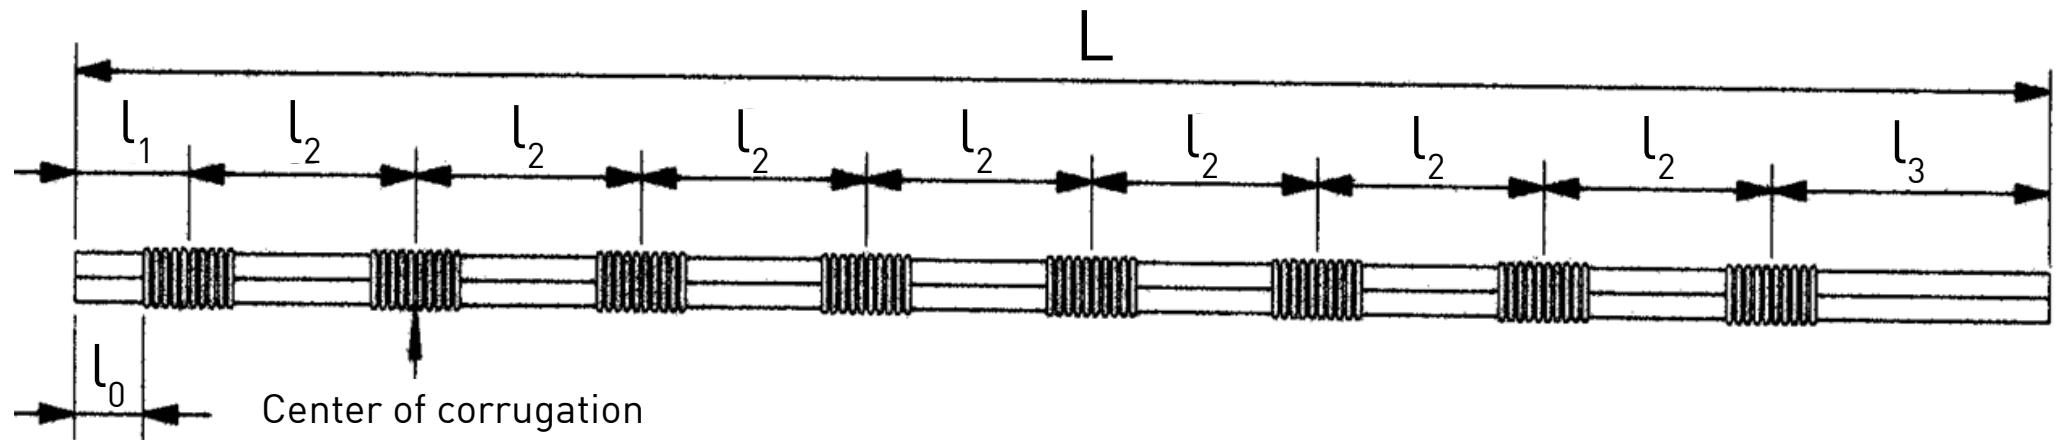
Name	L		l_1		l_2		l_3		l_0
	Standard	Tolerance	Standard	Tolerance	Standard	Tolerance	Standard	Tolerance	Standard
13 Su	4,000	± 0	190	+10 -0	475	± 20	485	± 0	150
20 Su			210		475		465		150
25 Su			210		475		465		150
30 Su			230		470		480		153.5
40 Su			265		460		515		152.5
50 Su			265		460		515		152.5

The total length (L), number of corrugations and the length of the corrugation can be altered upon request to the supplier.

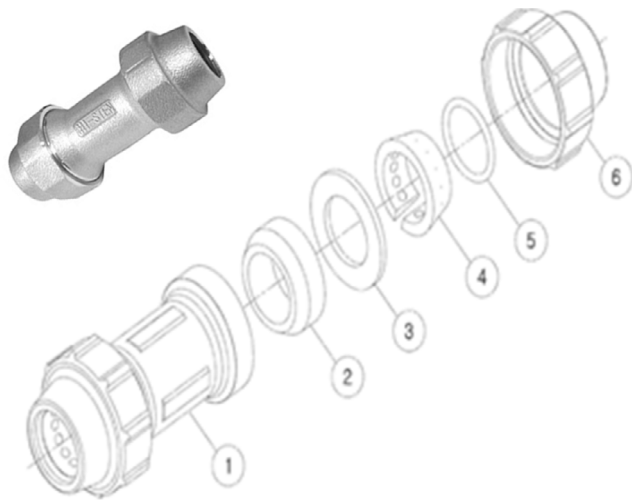
Specification (Joint) - made of cast stainless steel

Item	Description	Material
1	Body	SSC13/14
2	Packing	EPDM
3	Washer	STS304/316
4	Ball Guide	STS304/NYLON6
5	O-Ring	EPDM
6	Nut	SSC13/14

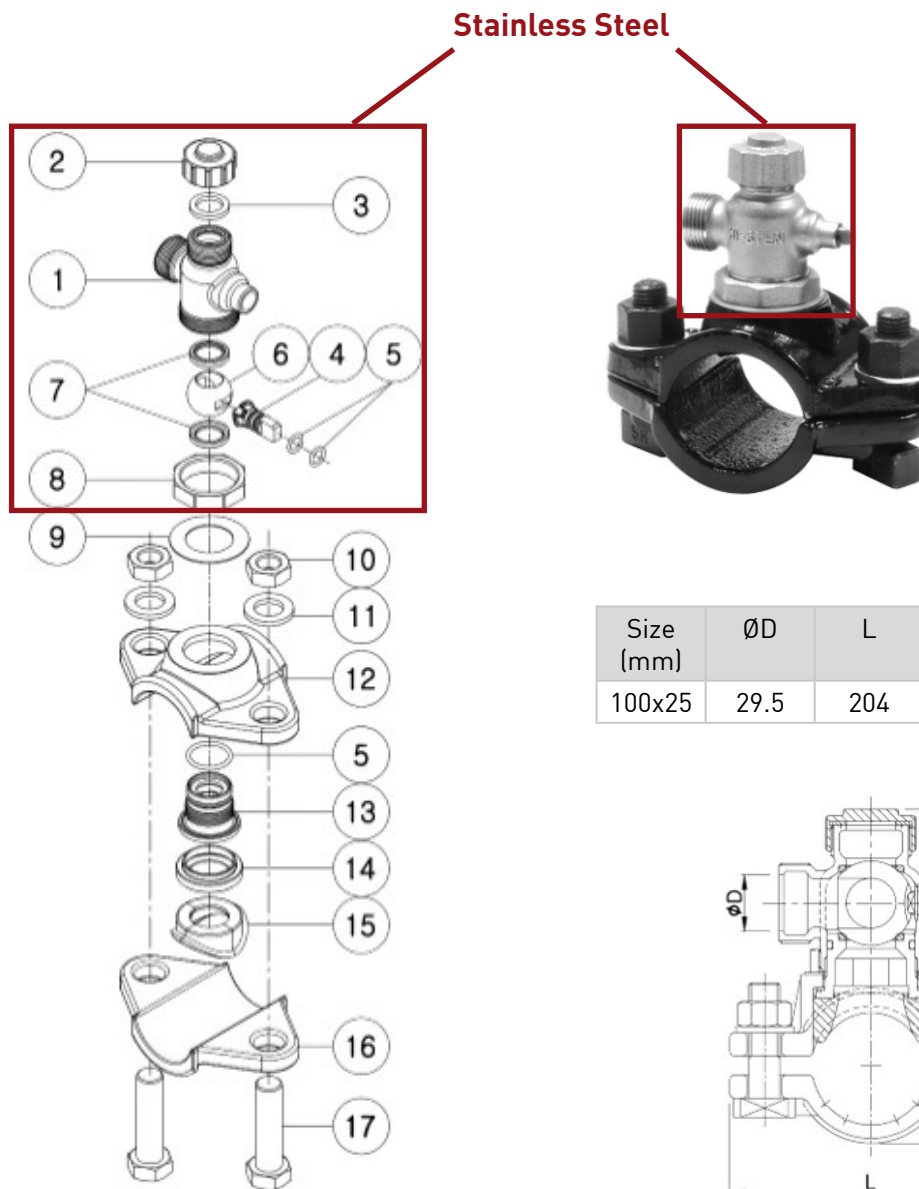
Specification (Snap Tap with Saddle) - made of cast stainless steel and carbon steel (ductile)

Item	Description	Material
1	Body	SSC13/14
2	Cap	SSC13/14
3	Cap Packing	EPDM
4	Stem	STS304/316
5	O-ring	EPDM
6	Ball	STS304/316
7	Seat	PTFE
8	Lock Nut	SSC13/14
9	Insulation Pad	PE
10	Nut	FCD450
11	Washer	SS400
12	Saddle	FCD450
13	Insert	SSC13/14
14	Insulation Guide	PE/EPDM
15	Upper Packing	EPDM
16	Band	FCD450
17	Bolt	FCD450

Size (mm)	ØD	L	H	H1	H2
100x25	29.5	204	231.8	182.8	49
