# The response of stream communities to earthquake derived sand & silt

*Jon Harding & Phil Jellyman*

*Freshwater Ecology Research Group  
School of Biological Sciences  
University of Canterbury*

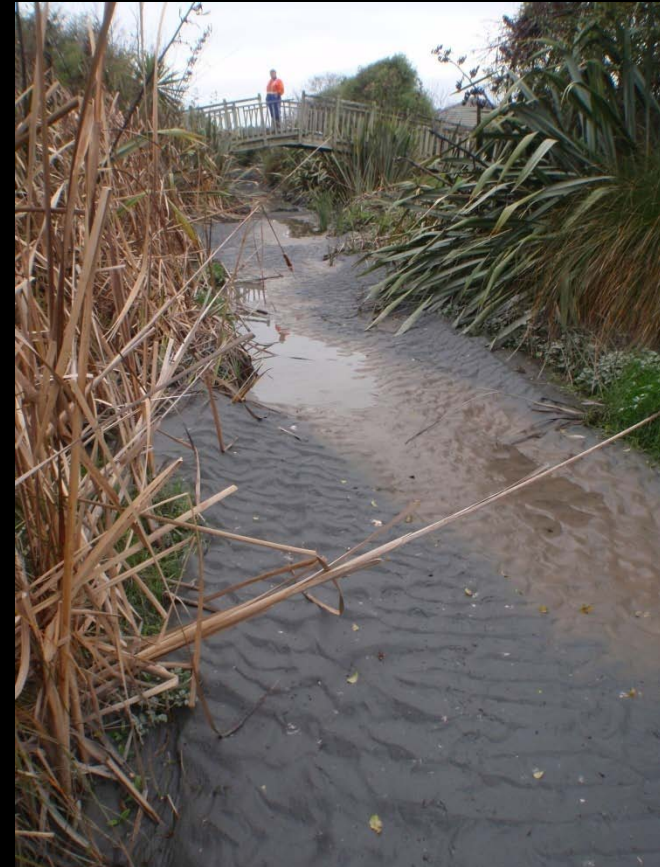
# Sediment depth pre- and post-earthquake (September 2011)
