Conference Paper · May 2016

## Leak Detection from the Buried Water Transmission Pipeline Using Landsat 8 Satellite Images (Case Study of the Kosar Water Transmission Pipeline)

### ABSTRACT

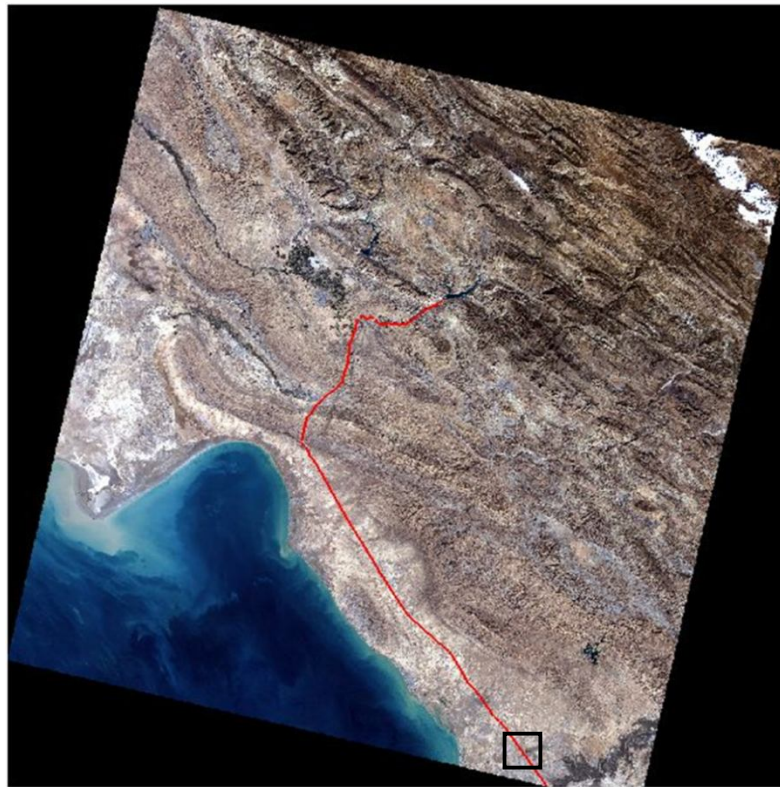
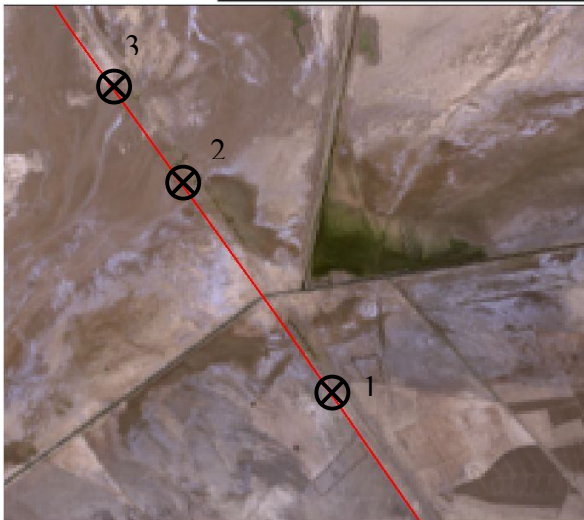
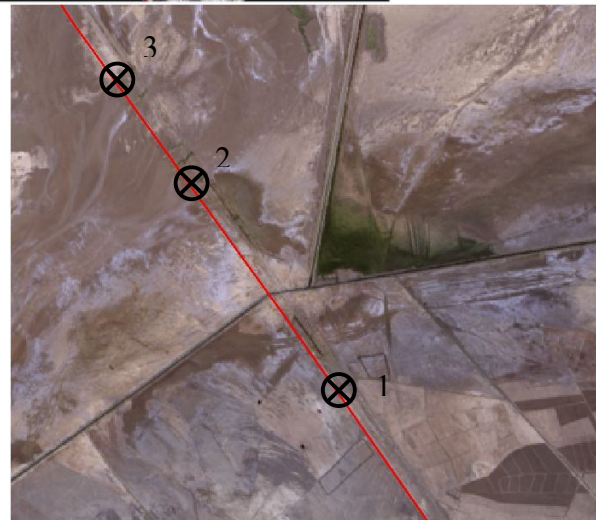
**Fig. 2.** (a) top: true-color Landsat 8 satellite image (Nov 06, 2014) over the Kosar water transmission pipeline, (b) left down: true-color image of leakage area (30-m pixel size) and (c) right down: pan sharpened image of leakage area (15-m pixel size).

This study was carried out using Landsat 8 images (such as the image of Nov 06, 2014) for multispectral and panchromatic modes (Figure 2). The date of images has been selected according to leakage information mentioned in Sec. 3. The study area has located in Zone 39 N based on the UTM projection system and satellite path 164 and row 39. Georeferenced vector data of the water transmission pipeline were used as ancillary data. ENVI 5.1 was used to perform

As can be seen in Figure 2(a), the main satellite image is larger than the pipeline area. So processing this image takes a lot of computer memory and time. Therefore, the first step in preprocessing is to create a buffer zone around the pipeline path. Radiometric corrections including the atmospheric correction, image fusion (Pan sharpened image, see Figure 2c) to obtain a high spatial resolution multispectral image through the combination of the multispectral image (low spatial resolution) with the panchromatic image (high spatial resolution) and image enhancement are other preprocessing steps that have been applied to the Landsat 8 images. Among the image enhancement techniques, Decorrelation Stretch is defined as the best technique compare to others according to the smallest standard deviation values for each band.
