# Stability Analysis of Flood Protection Embankments and Riverbank Protection Works

Rajib Kumar Goswami  
*Water Resources Department, India*

Baleshwar Singh  
*Indian Institute of Technology, India*

## Recent Advances in Geotechnical Earthquake Engineering and Soil Dynamics and Symposium in Honor of Professor I.M. Idriss

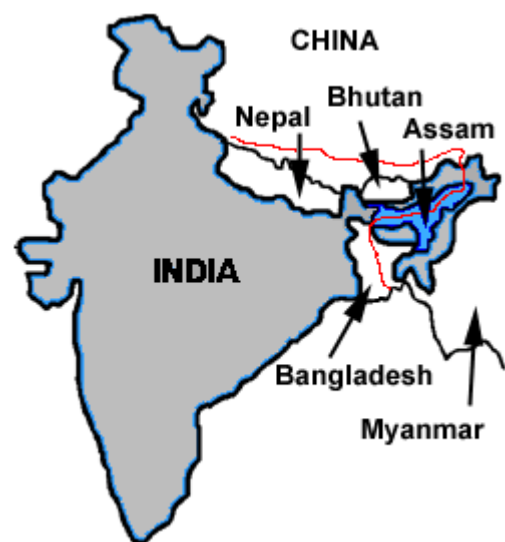
Fig. 1. The course of the Brahmaputra river

km from the origin to its mouth in the Bay of Bengal. In Assam, the river lies in a well-defined valley ranging from 40 to 100 km in width. In Figure 1, the river course is shown in red color whereas the state of Assam is shown in blue color.

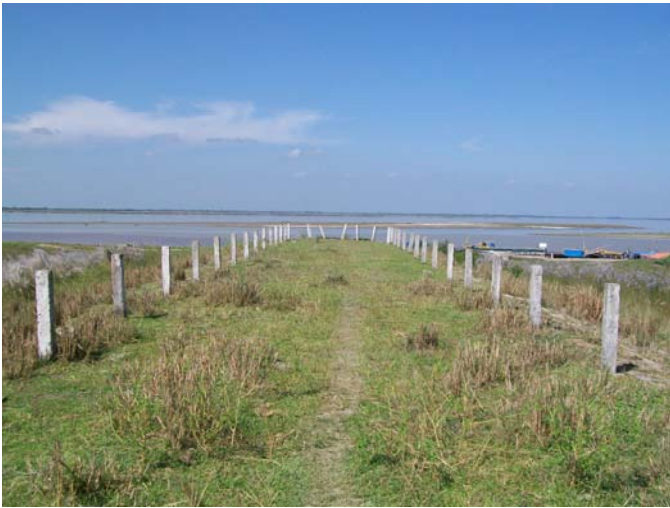
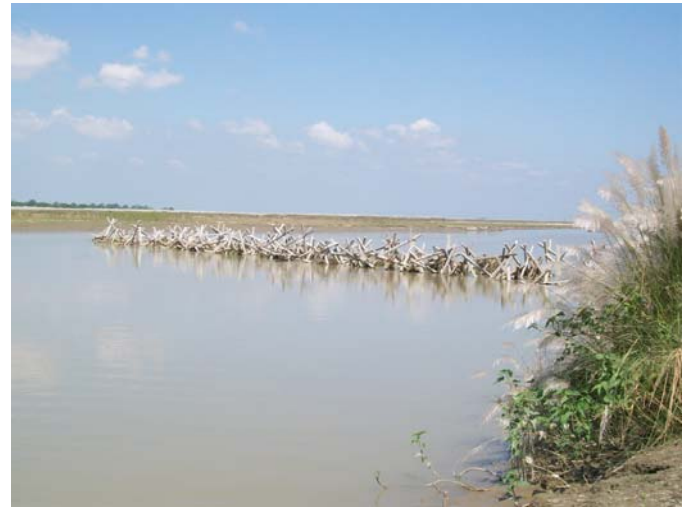
*Fig. 3. Views of a typical land spur constructed along the river*

Spurs are used to direct currents away from the riverbank and thereby protect the embankments. Two types have been used, namely land spurs and river spurs. Land spurs are constructed on the floodplain, perpendicular to and joined with the flood embankment. They are provided with riprap on the slope surfaces and a terminal rock apron placed in the river. Figure 3 shows various views of a land spur.

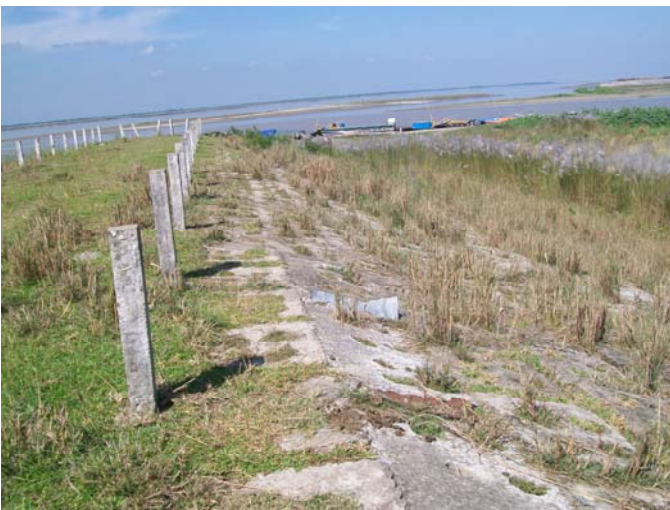
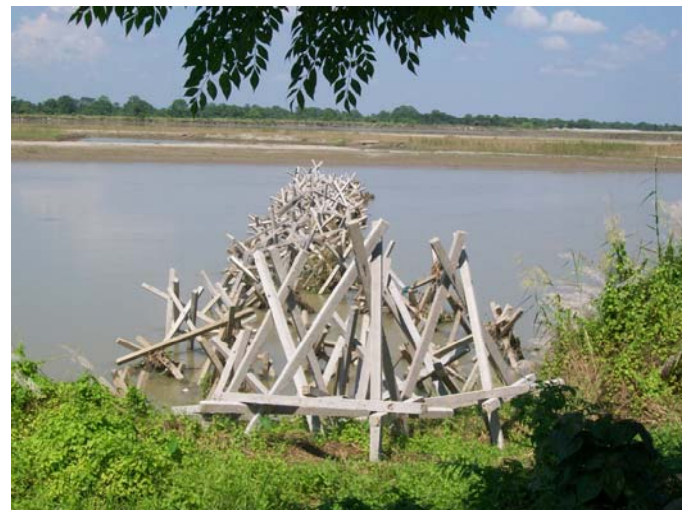
*Fig. 4. Views of a typical porcupine field installed in the river*

A revetment is a structure constructed at the bottom or on the banks of a river by placing a layer of material, such as rock, stones, concrete blocks, or mattresses. A porcupine is a tetrahedron-shaped concrete frame made of six concrete members each about 3 m long and connected with bolts, which are arrayed in the riverbed to retard flow and induce sedimentation. A porcupine field is shown in Figure 4.

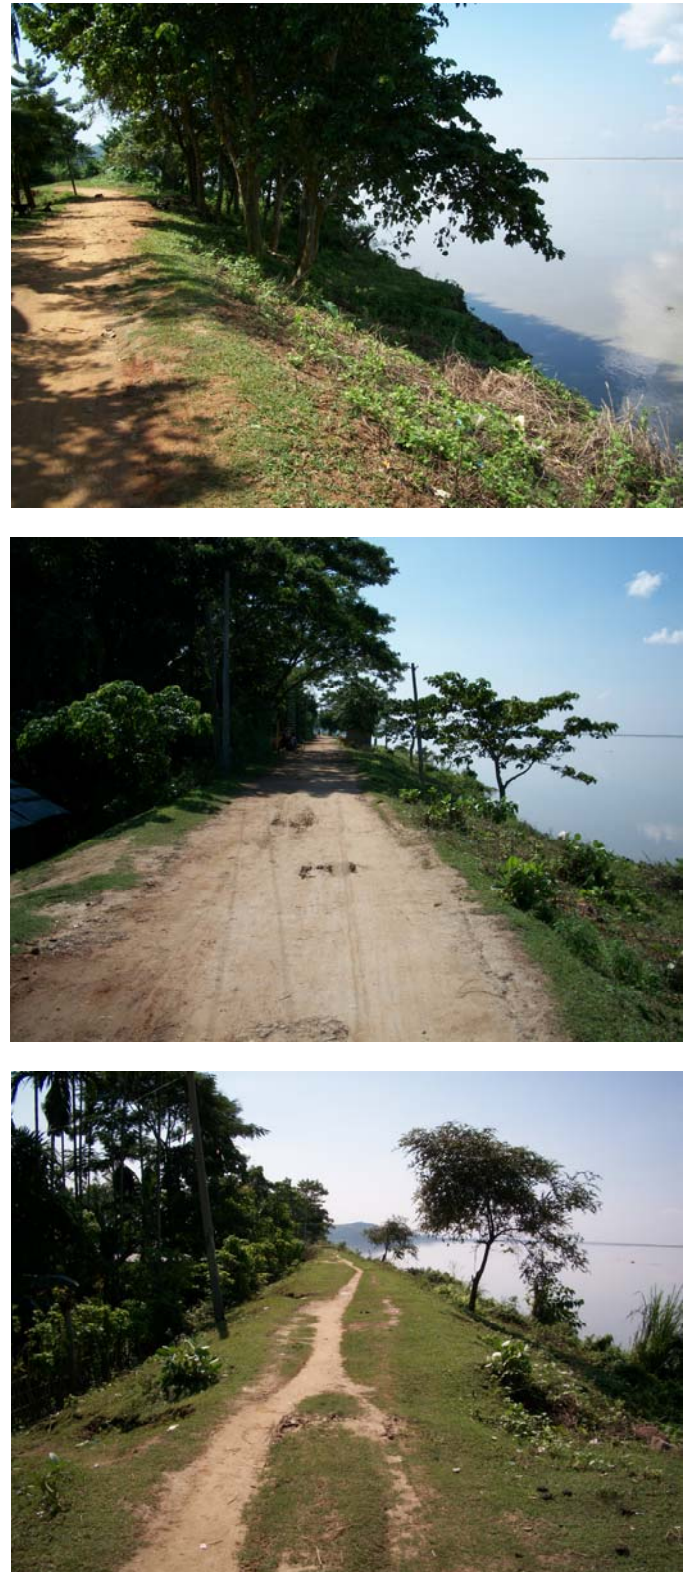
*Fig.5. Views of existing embankments at Palasbari next to the Brahmaputra river*

Some stretches of embankments just next to the riverbank can be seen from photographs presented in Figure 5.

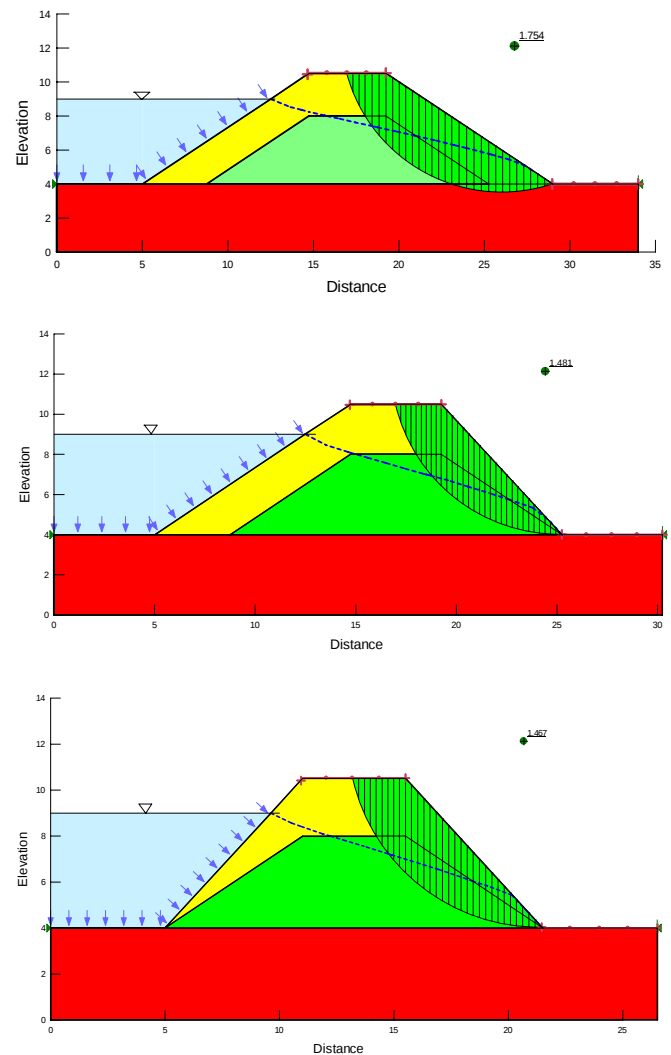
Fig. 6. Critical slip surfaces of different embankment sections under static conditions determined with Morgenstern and Price method

Under static conditions, the factors of safety determined for different methods of slope stability analysis are presented in Table 1. The critical slip surfaces of the three embankment sections obtained by using the Morgenstern and Price method are depicted serially in Figure 6.

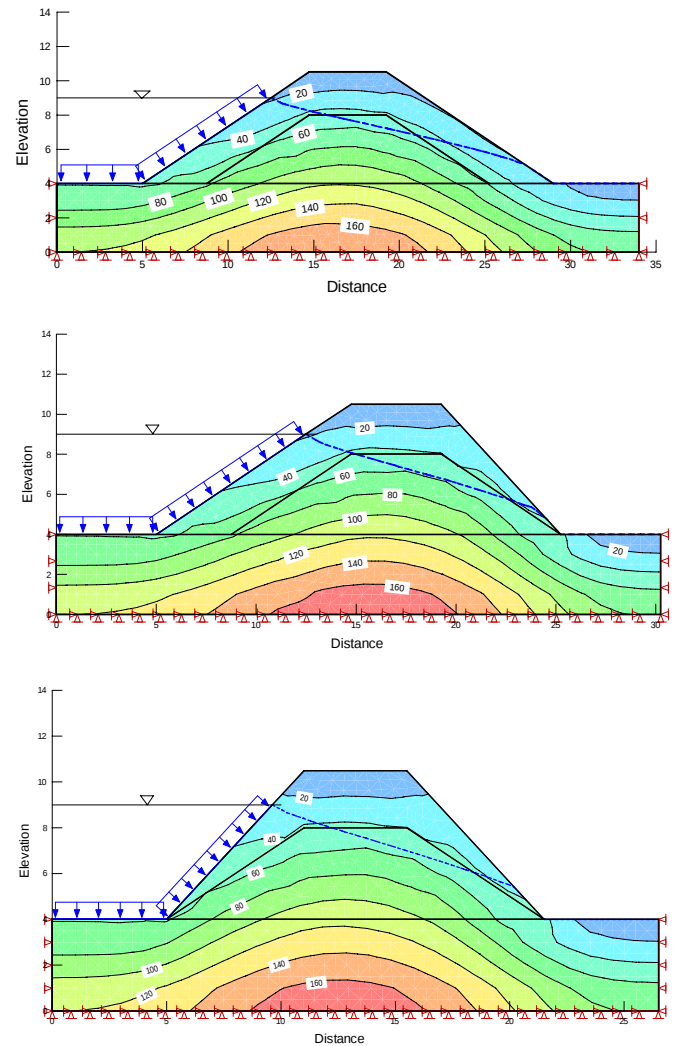
Fig. 7. Initial static stress contours of embankment sections

During earthquakes, the embankment sections may not completely collapse, but there may be unacceptable permanent deformation. In dynamic analysis, it is therefore necessary to estimate permanent deformations that can occur as a result of inertial forces associated with an earthquake. For this, the first step is to determine the in-situ state of stress in the ground which exists before the earthquake occurs and then shakes the ground. Initial stress contour plots of the three final embankment sections are shown in Figure 7.

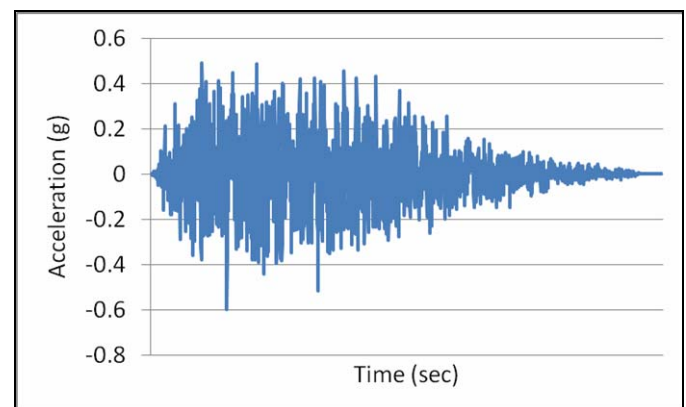
Fig. 8. Typical acceleration-time history

In the next step, the embankments are subjected to an earthquake acceleration-time history of 44.3 sec duration, as shown in Figure 8. The data for this record has a constant time interval of 0.02 sec. A procedure similar to Newmark method of analysis has been used to examine the stability and determine the permanent deformation during the earthquake.

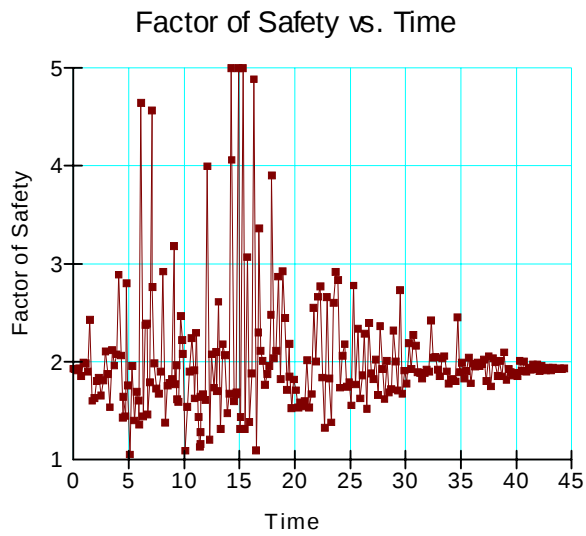
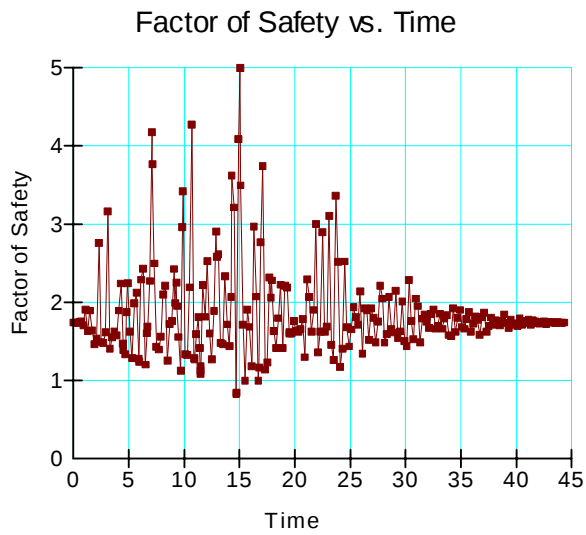
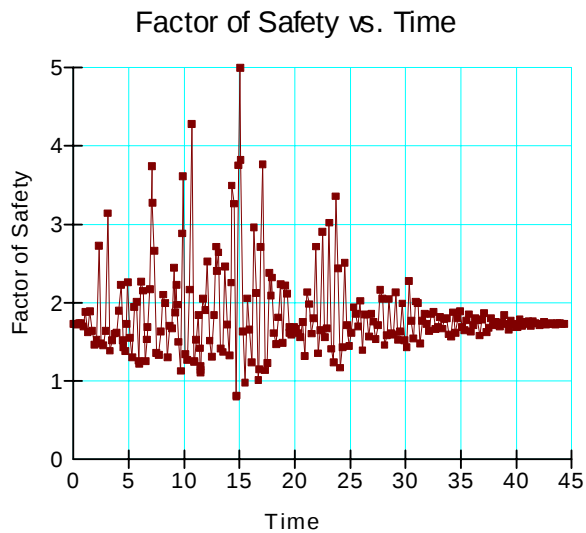
Fig. 9. Variations of factor of safety with time of the embankment sections under dynamic loading

Figure 9 describes the variations of factor of safety with time for the three embankment sections. It can be noted that the factor of safety goes up when the shaking is towards the riverside. As there is a wide variation in the factors of safety during the earthquake, it is difficult to state anything meaningful about the stability of the embankments. During the shaking period, there are short time moments when the initial static forces plus the inertial forces exceed the available shear resistance. During these times, there is a temporary loss of stability that leads to unrecoverable deformations. These deformations accumulate and result as permanent deformation after the shaking is over.

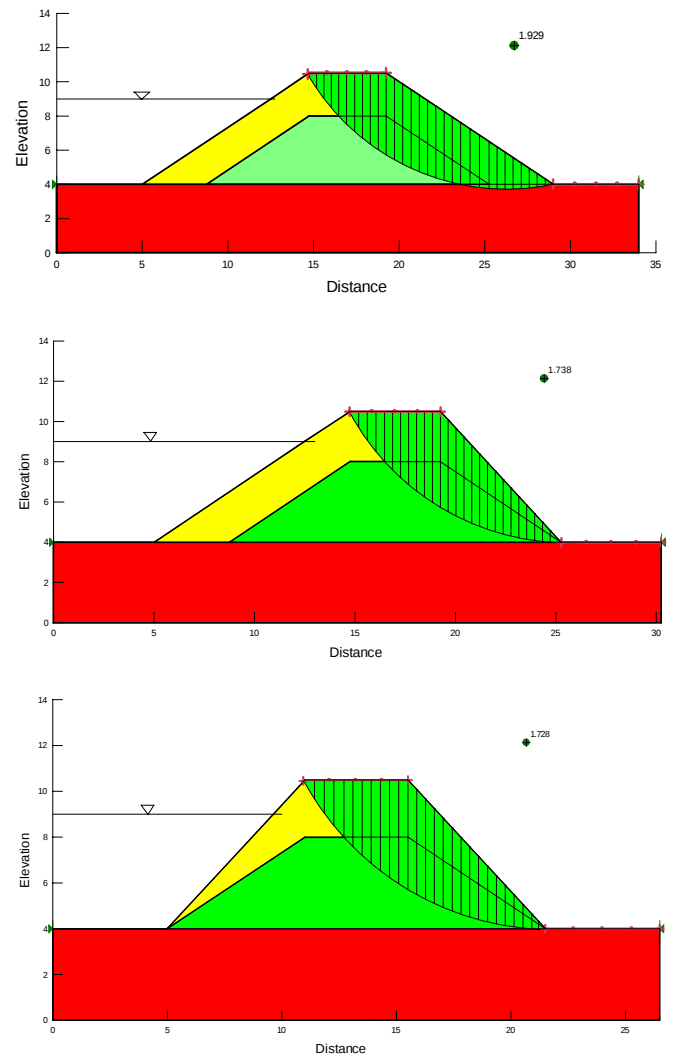
Fig. 10. Critical slip surfaces with the largest deformations of the embankment sections under dynamic loading

It is then possible to identify the particular slip surface on which the largest computed deformation occurs. These specific critical slip surfaces for the three embankment sections are presented in Figure 10.

The corresponding factors of safety and the permanent deformations for these particular slip surfaces are tabulated in Table 2. It can be observed that there is no permanent deformation for Section I, in which the embankment is widened in both the sides. All the three sections are safe but the steep side slopes should be stabilized immediately after construction so as to prevent gully and rut formation. Therefore, the new embankment slopes should be vegetated as soon as possible.

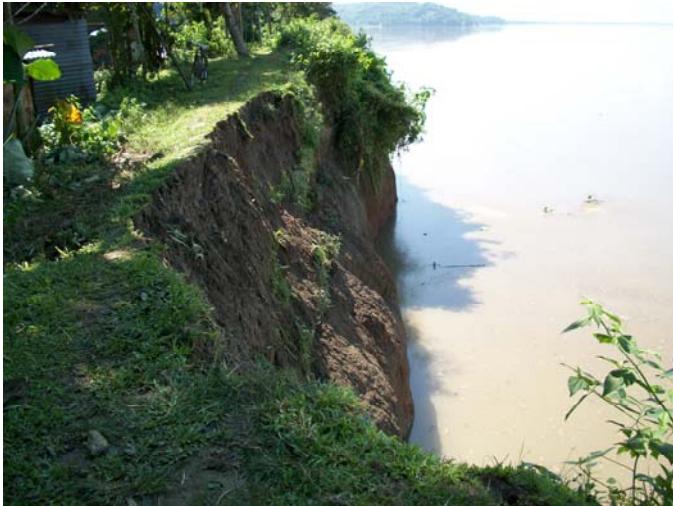
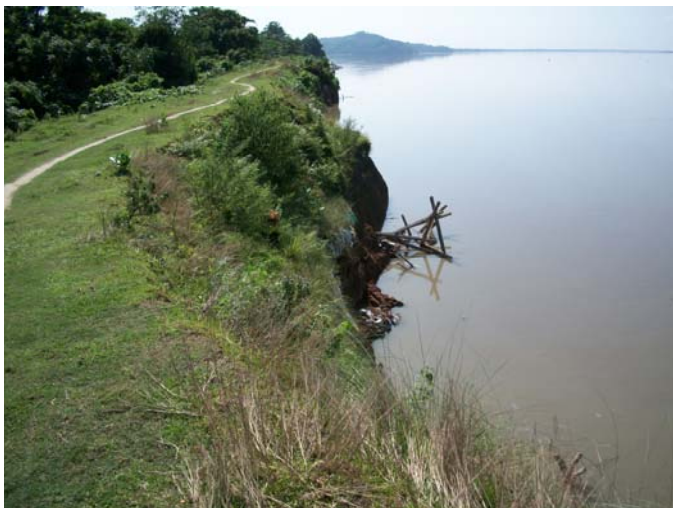
*Fig. 11. Some views of riverbank erosion at Palasbari*

The riverbank has eroded severely in several portions at Palasbari as observed from photographs shown in Figure 11.

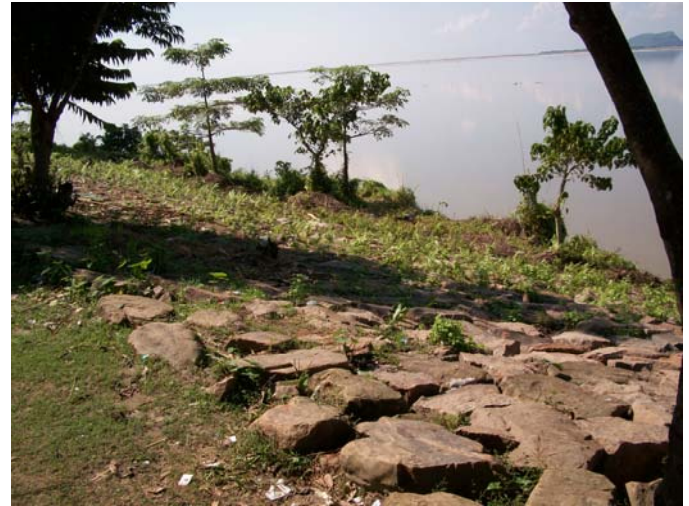
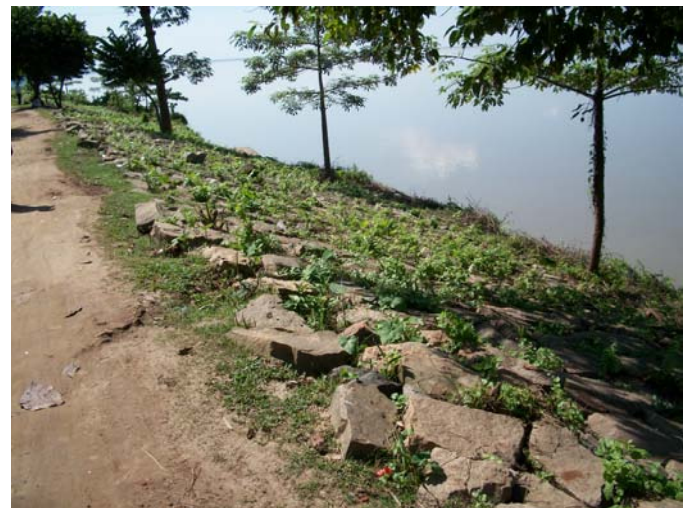
*Fig. 12. Existing revetment riverbank protection at Palasbari*

The riverbank revetment protection measures that exist only at certain portions along the Palasbari reach can be seen from photographs depicted in Figure 12.
