Comparative Study of Mosul and Haditha Dams, Iraq: Foundation Treatments in the Two Dams

**Nasrat Adamo¹, Varoujan K. Sissakian², Nadhir Al-Ansari¹, Sven Knutsson¹
Jan Laue¹ and Malik Elagely³**

Abstract

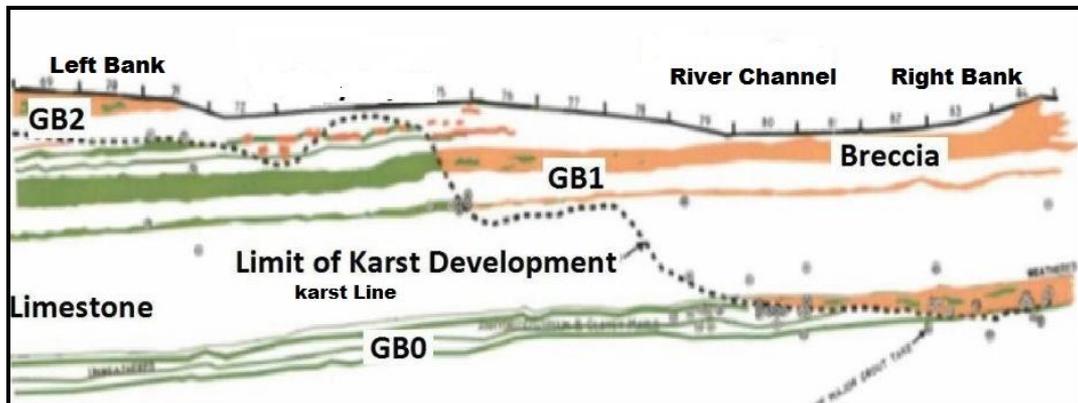
Figure 1: Mosul Dam Designer's visualization of the karst line in dam foundation [Note the existence of GB0 below the so called "Karst Line"]

The criteria specified by the designer for the deep grout curtain were to aim at getting water tightness of 2 Lugeon at the upper part of the curtain and 5 Lugeon in the lower part of it. This could not be achieved due to the resistance of the brecciated gypsum beds (GB0, GB1, BB2, GB3) to the penetration of grouts and /or not being able to hold these grouts for a long time, in spite of using all possible combinations of grout mixes and grouting methods and procedures. To understand the behaviour of these brecciated gypsum beds one may refer to [5] to see how they start and develop. As dissolution is initiated within a cavity, joint or crack within a gypsum bed by seepage water the gradually increased flow invigorate further dissolution of gypsum and causes the enlargement of the cavities in different shapes and extents. In Mosul Dam, such dissolution in most cases starts within the interface of gypsum with the badly cracked and fissured marl and limestone beds and, furthermore clay filling is washed inside the cavity from the marly layers on top through the cracked and jointed limestone. The resulting breccias are a complex of gypsum fragments, anhydrite and limestone chips and blocks which are locked in fine clay matrix. Such structure did not respond to any type or procedure of grouting and when trials were partially successful, the brecciated gypsum beds could not hold on the grout and dissolution, piping and washing away of the filling material starts all over again (Figure 2). This type of karst may be considered as one of the worst types and should be avoided in hydraulic works if possible, or to avoid grouting it as an anti-seepage measure. Replacement of this material could be done if it is at the surface or at shallow depth, otherwise using positive cut-off such as slurry trenches or concrete diaphragm walls may provide the solution

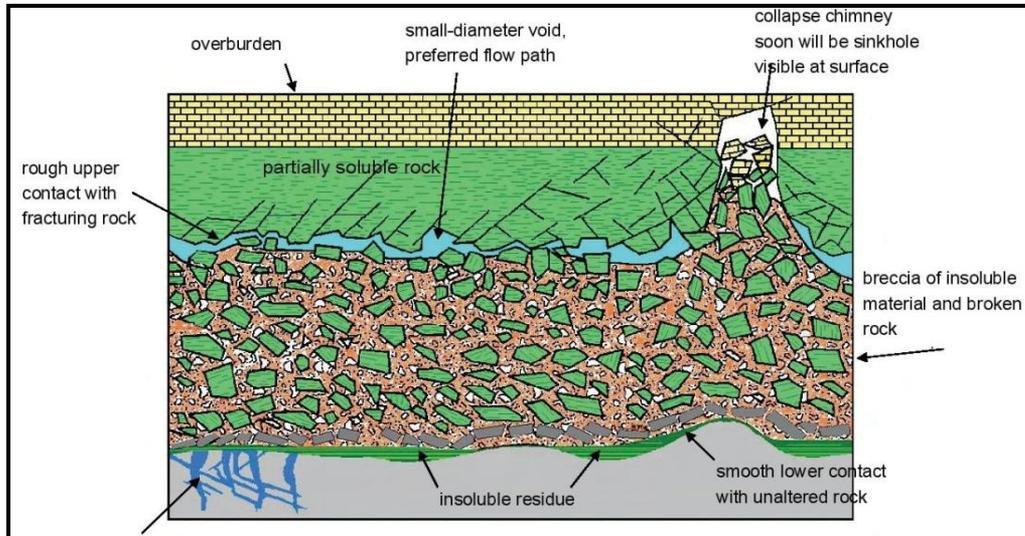
Figure 2: Brecciated gypsum beds' formation processes [5]

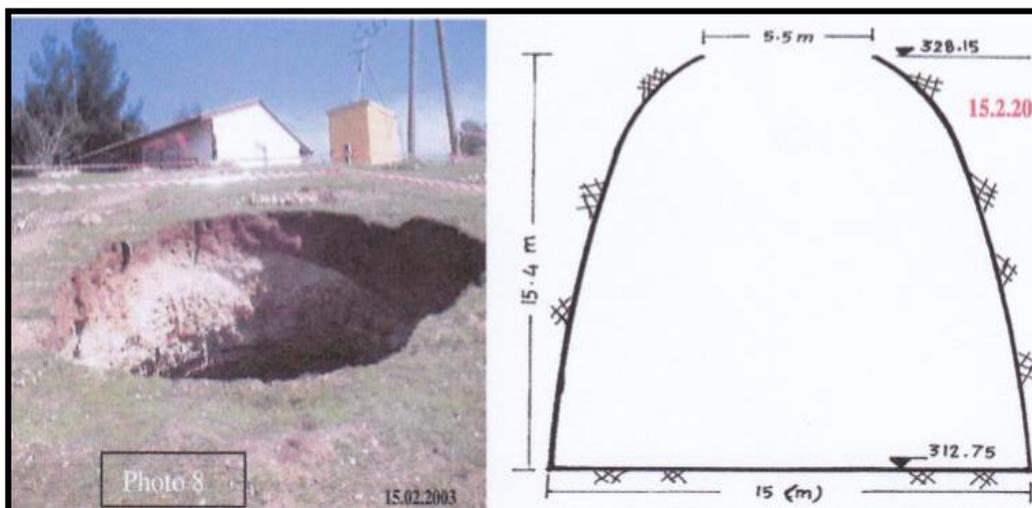
Figure 3: The sinkhole on the left bank close to the downstream of the dam, appeared on 15th February 2015

It is worth noting that one Lugeon unit is equal to a permeability of 1.3×10^{-5} cm/sec. All efforts to get a good curtain failed before impounding the reservoir and there were what was called “open windows” during the impounding and afterwards that resulted in a worsening situation leading to the intensive maintenance grouting program which is continuous up to the present date. During the filling and operation years, many sinkholes developed on the ground surface; first, at the right rim of the reservoir, and then followed by other sinkholes in the right bank, and later on in the left bank (Figure 3), shows the sinkhole at the left bank which appeared on 15th of February 2003.

These sinkholes were all close to the downstream of the main dam. Sinkholes were discovered also afterwards in the floor of the reservoir very close to the dam during a bathymetric survey performed in 2013 [6], which showed the formation of numerous dissolution sinkholes, and indicating direct link between the reservoir and the ground water aquifer extending all around the dam and connecting to the downstream. In 2005, a Panel of Experts postulated in a study on Mosul Dam that this dam could fail due to karsts development in the form of sinkholes with limited or no warning time [7], [8]. In 2006, another Panel of Experts decided that the formation of these sinkholes represent such a hazard to the dam that it threatened it with immediate collapse and recommended in 2007 to reduce the maximum operation water level from design elevation 330.00 m (a.s.l.) to elevation 319.00 m (a.s.l.).

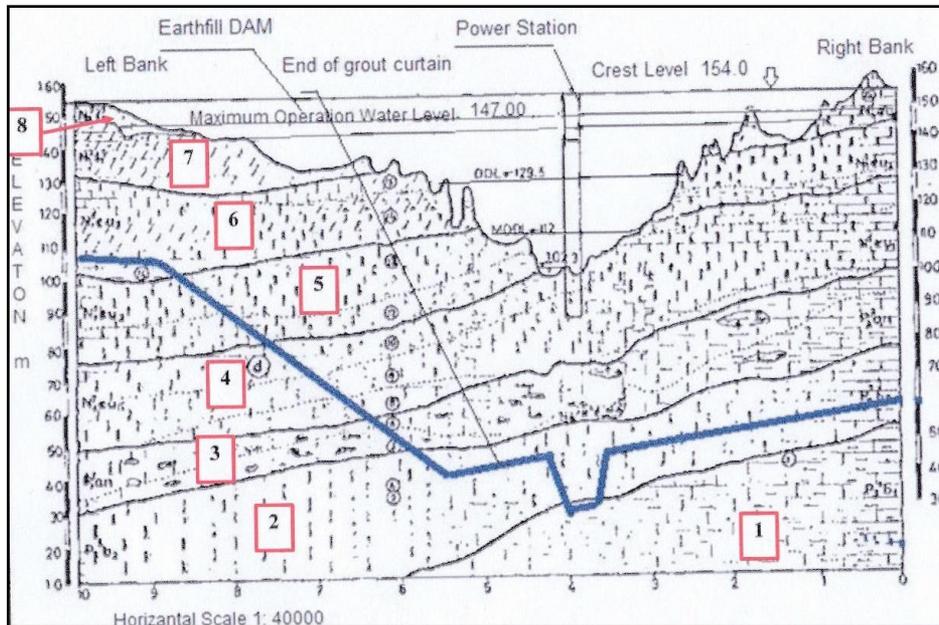
Figure 4: Geological cross section under the dam and Powerhouse- Spillway Structure, showing the lower limits of the grout curtain
